## **Access Compliance Report Public Rights-of-Way** (Curb Ramps)

Intersection ID: 29469 Main Street: BROOKCHASE LN **Cross Street: DOWNING ST** Location: W **Overall Compliance: No Severity Score:** 25 ADA ID: 15DC420F6A71 Ramp Type: PerpDiag Initial Pass/Fail: Fail

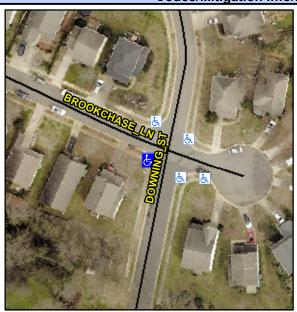
Yes Ramp Slope (%) Ramp Length (in) 53.5 7.7 No Ramp XSlope (%) Ramp Width (in) 48.0 7.7 Flare Type LT N/A N/A Flare Type RT N/A N/A N/A Flare Slope RT (%) N/A Flare Slope LT (%) Flare Traversable LT? N/A N/A Flare Traversable RT? N/A N/A N/A **DWS Provided?** N/A Landing Length (in) Landing Width (in) N/A N/A **DWS Contrast?** N/A N/A N/A Landing Slope (%) DWS Length (in) N/A Landing X Slope (%) N/A N/A DWS Full Width? N/A Landing Curb? (Y/N) N/A N/A DWS Offset (in) N/A N/A Shared Landing? **Gutter Ponding?** N/A N/A Gutter Slope (%) N/A Gutter Lip Ht (in) N/A N/A Gutter X Slope (%) N/A Painted X Walk1? No N/A Painted X Walk2? No X Walk 1 Direction To NE X Walk 2 Direction To SE N/A X Walk 1 Width (in) X Walk 2 Width (in) N/A 0.8 X Walk 2 Slope (%) 3.5 X Walk 2 X Slope (%) X Walk 1 X Slope (%) 6.8 3.2 N/A N/A Ramp inside XWalk2? N/A Ramp inside XWalk1? 3.1 N/A Clear Space? N/A N/A 6.8 Clear Space to XWalk (in) N/A N/A N/A Storm Grate/Utility Hazard? N/A Storm Grate/Utility Type N/A N/A Yes Surface Condition? (G/P) Good

Possible Solutions: Remove & Replace Curb Ramp With Two New Directional Ramps or Equivalent. Surveyor Notes: N/A PROW/ADA: R304.5.3
