# Access Compliance Report

## Public Rights-of-Way

### (Curb Ramps)

| Intersection ID: 14844 | Main Street: DILWORTH_RD_WEST | Cross Street: EAST_BV | Location: SE |

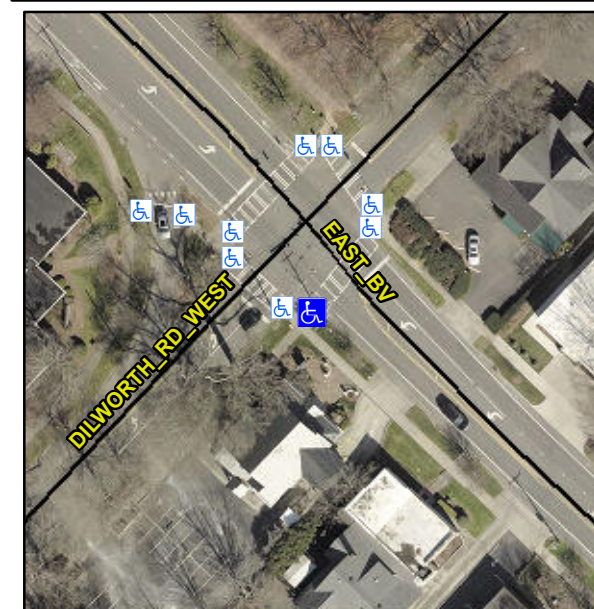
**R304.5.3, R304.2.2-Perp, R304.3.2-  
Para, R302.7, R304.5.4**

| Compliance | Description | Data | Compliance | Description | Data |
|---|---|---|---|---|---|
| No | Ramp XSlope (%) | 2.1 | | | |
| No | Landing Slope (%) | 3.1 | Yes | DWS Length (in) | 25.5 |
| No | Gutter Ponding? | Yes | No | Gutter Slope (%) | 7.3 |

**Remove & Replace Entire Ramp.  
Remove & Replace Gutter.**

Total Cost: \$ 2350.00
