## Access Compliance Report Public Rights-of-Way (Curb Ramps)

Intersection ID: 10026441 Main Street: FARMHURST\_DR Cross Street: N/A Location: NE

ADA ID: 15DD789031D5 Ramp Type: PerpDiag Initial Pass/Fail: Fail Overall Compliance: No Severity Score: 21.25

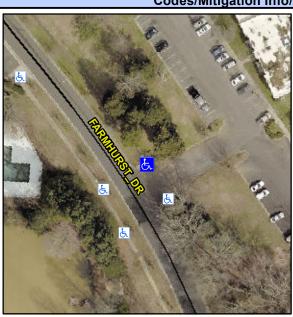
Not Found, R304.5.1, R304.2.2

Comp	liance Description	Data	Comp	liance	Description	Data
N/A	Ramp Length (in)	91.0	No	Ram	Slope (%)	10.1
No	Ramp Width (in)	41.0	Yes	Ram	XSlope (%)	0.2
N/A	Flare Type LT	N/A	N/A	Flare	Type RT	N/A
N/A	Flare Slope LT (%)	N/A	N/A	Flare	Slope RT (%)	N/A
N/A	Flare Traversable LT?	N/A	N/A	Flare	Traversable RT?	N/A
N/A	Landing Length (in)	N/A	N/A	DWS	Provided?	N/A
N/A	Landing Width (in)	N/A	N/A	DWS	Contrast?	N/A
N/A	Landing Slope (%)	N/A	N/A	DWS	Length (in)	N/A
N/A	Landing X Slope (%)	N/A	N/A	DWS	Full Width?	N/A
N/A	Landing Curb? (Y/N)	N/A	N/A	DWS	Offset (in)	N/A
N/A	Shared Landing?	N/A				
N/A	Gutter Ponding?	N/A	N/A	Gutte	er Slope (%)	N/A
N/A	Gutter Lip Ht (in)	N/A	N/A	Gutte	er X Slope (%)	N/A
N/A	Painted X Walk1?	No	N/A	Paint	ed X Walk2?	No
	X Walk 1 Direction	To SW		X Wa	lk 2 Direction	To S
N/A	X Walk 1 Width (in)	N/A	N/A	X Wa	lk 2 Width (in)	N/A
	X Walk 1 Slope (%)	1.5		X Wa	lk 2 Slope (%)	2.7
	X Walk 1 X Slope (%)	2.3		X Wa	lk 2 X Slope (%)	0.6

N/A	Ramp inside XWalk1?	N/A	N/A	Ram	o inside XWalk2?	N/A
	Road Slope (%)	0.5	N/A	Clear	Space?	N/A
	Road X Slope (%)	1.2	N/A	Clear	Space to XWalk (in)	N/A
N/A	Any Obstructions?	N/A	N/A	Storn	n Grate/Utility Hazard?	N/A
	Obstruction Type			Storn	n Grate/Utility Type	
		N/A				N/A

Equivalent.

Remove & Replace Curb Ramp With Two New Directional Ramps or

Total Cost: \$ 3200.00
