Access Compliance Report

Public Rights-of-Way

(Curb Ramps)

Intersection ID: 12677	Main Street: HICKORY_TRACE_DR	Cross Street: PENCE_RD	Location: NE
ADA ID: 15DF8C413F54	Ramp Type: Perp	Initial Pass/Fail: Fail	Overall Compliance: No
Codes/Mitigation Info/Possible Solution		Field Measurements/Component Compliance	
Severity Score: 21.25

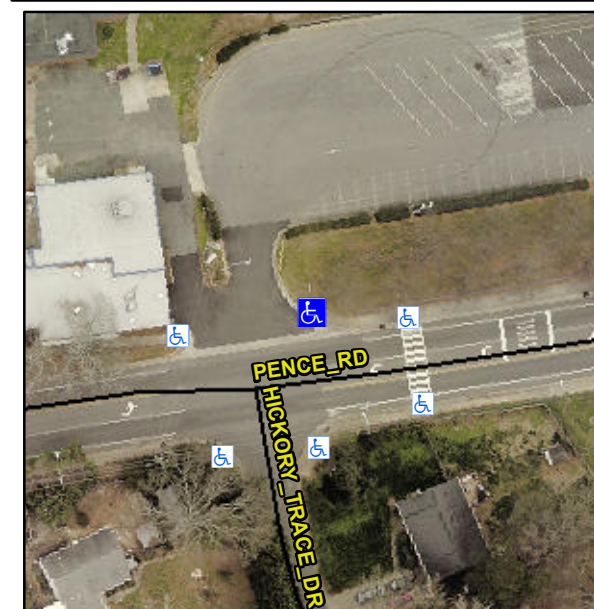
Not Found, R304.5.1, R304.2.2

Compliance	Description	Data	Compliance	Description	Data
N/A	Ramp Length (in)	72.0	No	Ramp Slope (%)	9.6
No	Ramp Width (in)	37.5	Yes	Ramp XSlope (%)	0.7
N/A	Flare Type LT	N/A	N/A	Flare Type RT	N/A
N/A	Flare Slope LT (%)	N/A	N/A	Flare Slope RT (%)	N/A
N/A	Flare Traversable LT?	N/A	N/A	Flare Traversable RT?	N/A
N/A	Landing Length (in)	N/A	N/A	DWS Provided?	N/A
N/A	Landing Width (in)	N/A	N/A	DWS Contrast?	N/A
N/A	Landing Slope (%)	N/A	N/A	DWS Length (in)	N/A
N/A	Landing X Slope (%)	N/A	N/A	DWS Full Width?	N/A
N/A	Landing Curb? (Y/N)	N/A	N/A	DWS Offset (in)	N/A
N/A	Shared Landing?	N/A			
N/A	Gutter Ponding?	N/A	N/A	Gutter Slope (%)	N/A
N/A	Gutter Lip Ht (in)	N/A	N/A	Gutter X Slope (%)	N/A
N/A	Painted X Walk1?	No	N/A	Painted X Walk2?	N/A
	X Walk 1 Direction	To S		X Walk 2 Direction	N/A
N/A	X Walk 1 Width (in)	N/A	N/A	X Walk 2 Width (in)	N/A
	X Walk 1 Slope (%)	3.2		X Walk 2 Slope (%)	N/A
	X Walk 1 X Slope (%)	3.8		X Walk 2 X Slope (%)	N/A

Possible Solutions:

Remove & Replace Entire Ramp.
