## **Access Compliance Report Public Rights-of-Way** (Curb Ramps)

Intersection ID: 10041481 Main Street: WESTPARK DR **Cross Street: N/A** Location: NW ADA ID: 15E5636D4A19 Ramp Type: PerpDiag Initial Pass/Fail: Pass **Overall Compliance: No** Severity Score: 15.25

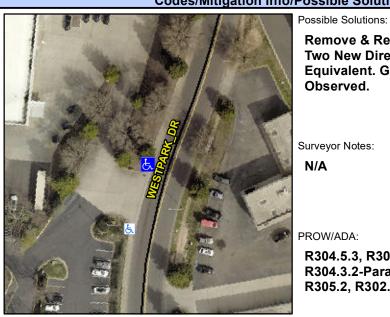
Compliance Description Da		Data	Comp	oliance Description	Data
N/A	Ramp Length (in)	60.0	Yes	Ramp Slope (%)	6.9
Yes	Ramp Width (in)	48.0	No	Ramp XSlope (%)	3.0
N/A	Flare Type LT	Sloped	N/A	Flare Type RT	N/A
N/A	Flare Slope LT (%)	1.8	No	Flare Slope RT (%)	10.7
N/A	Flare Traversable LT?	Yes	N/A	Flare Traversable RT?	Yes
No	Landing Length (in)	N/A	Yes	DWS Provided?	Yes
No	Landing Width (in)	N/A	Yes	DWS Contrast?	Yes
No	Landing Slope (%)	N/A	No	DWS Length (in)	23.0
No	Landing X Slope (%)	N/A	No	DWS Full Width?	No
N/A	Landing Curb? (Y/N)	No	No	DWS Offset (in)	7.0
N/A	Shared Landing?	N/A			
No	Gutter Ponding?	Yes	Yes	Gutter Slope (%)	2.1
Yes	Gutter Lip Ht (in)	0.0	Yes	Gutter X Slope (%)	2.0
N/A	Painted X Walk1?	No	N/A	Painted X Walk2?	No
	X Walk 1 Direction	To S		X Walk 2 Direction	То Е
N/A	X Walk 1 Width (in)	N/A	N/A	X Walk 2 Width (in)	N/A
	X Walk 1 Slope (%)	1.4		X Walk 2 Slope (%)	2.7
	X Walk 1 X Slope (%)	8.6		X Walk 2 X Slope (%)	0.1

N/A	Ramp inside XWalk1?	N/A	N/A	Ramp inside XWalk2?	N/A
	Road Slope (%)	2.8	N/A	Clear Space?	Yes
	Road X Slope (%)	0.0	N/A	Clear Space to XWalk (in)	N/A
Yes	Any Obstructions?	No	Yes	Storm Grate/Utility Hazard?	No
	Obstruction Type			Storm Grate/Utility Type	
		N/A			N/A
			Yes	Surface Condition? (G/P)	Good

Remove & Replace Curb Ramp With Two New Directional Ramps or **Equivalent. Gutter Ponding** Observed.

R304.5.3, R304.2.1, R304.2.2-Perp, R304.3.2-Para, R304.2.3, R305.1.4, R305.2, R302.7
