Access Compliance Report

Public Rights-of-Way

(Curb Ramps)

Intersection ID: 23901	Main Street: KEMPSHOTT_CT	Cross Street: LAMPMEADE_LN	Location: NE
ADA ID: 15E816CD50D8	Ramp Type: PerpDiag	Initial Pass/Fail: Fail	Overall Compliance: No
Codes/Mitigation Info/Possible Solution		Field Measurements/Component Compliance

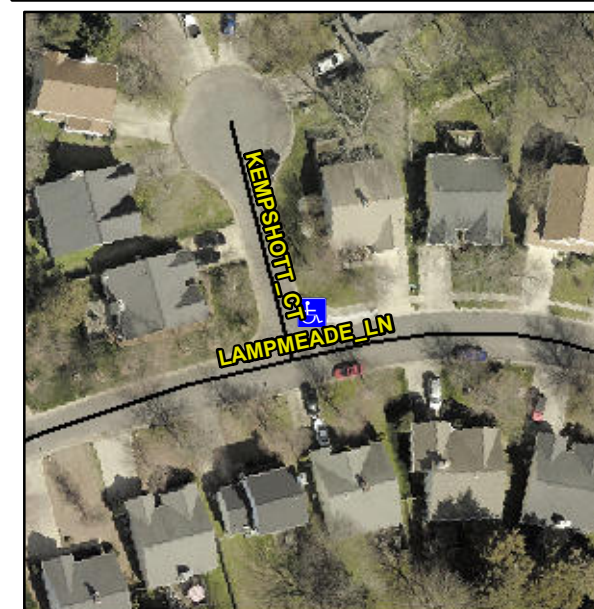
Compliance	Description	Data	Compliance	Description	Data
N/A	Ramp Length (in)	96.0	No	Ramp Slope (%)	13.0
No	Ramp Width (in)	39.0	Yes	Ramp XSlope (%)	0.5
N/A	Flare Type LT	N/A	N/A	Flare Type RT	N/A
N/A	Flare Slope LT (%)	N/A	N/A	Flare Slope RT (%)	N/A
N/A	Flare Traversable LT?	N/A	N/A	Flare Traversable RT?	N/A
N/A	Landing Length (in)	N/A	N/A	DWS Provided?	N/A
N/A	Landing Width (in)	N/A	N/A	DWS Contrast?	N/A
N/A	Landing Slope (%)	N/A	N/A	DWS Length (in)	N/A
N/A	Landing X Slope (%)	N/A	N/A	DWS Full Width?	N/A
N/A	Landing Curb? (Y/N)	N/A	N/A	DWS Offset (in)	N/A
N/A	Shared Landing?	N/A			
N/A	Gutter Ponding?	N/A	N/A	Gutter Slope (%)	N/A
N/A	Gutter Lip Ht (in)	N/A	N/A	Gutter X Slope (%)	N/A
N/A	Painted X Walk1?	No	N/A	Painted X Walk2?	No
	X Walk 1 Direction	To W		X Walk 2 Direction	To S
N/A	X Walk 1 Width (in)	N/A	N/A	X Walk 2 Width (in)	N/A
	X Walk 1 Slope (%)	3.4		X Walk 2 Slope (%)	6.2
	X Walk 1 X Slope (%)	2.8		X Walk 2 X Slope (%)	0.1

N/A	Ramp inside XWalk1?	N/A	N/A	Ramp inside XWalk2?	N/A
	Road Slope (%)	1.5	N/A	Clear Space?	N/A
	Road X Slope (%)	2.4	N/A	Clear Space to XWalk (in)	N/A
N/A	Any Obstructions?	N/A	N/A	Storm Grate/Utility Hazard?	N/A
	Obstruction Type			Storm Grate/Utility Type	
		N/A			N/A
			Yes	Surface Condition? (G/P)	Good

Remove & Replace Curb Ramp With Two New Directional Ramps or Equivalent.

R304.5.1, R304.2.2
