Access Compliance Report

Public Rights-of-Way

(Curb Ramps)

Intersection ID: 20427	Main Street: PROVIDENCE_RD	Cross Street: JEFFERSON_DR	Location: NW
ADA ID: 15EE964CB315	Ramp Type: Directional1	Initial Pass/Fail: Fail	Overall Compliance: No
		Severity Score: 12.5

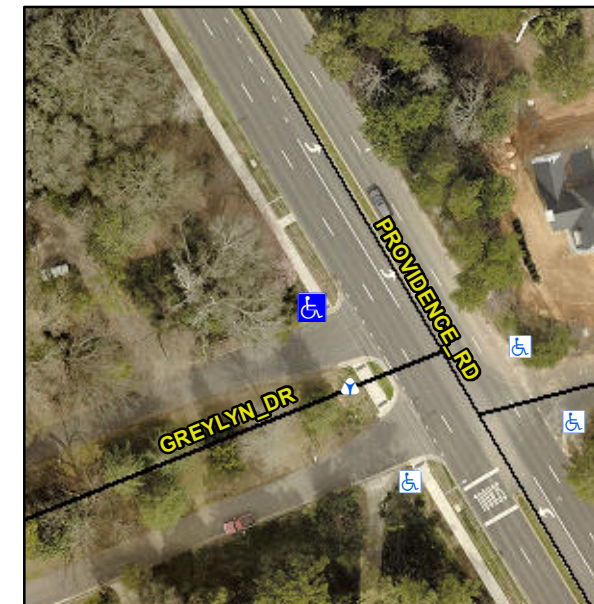
Compliance	Description	Data	Compliance	Description	Data
N/A	Ramp Length (in)	67.0	N/A	Grade Break?	N/A
Yes	Ramp Width (in)	70.0	N/A	Grade Break Slope (%)	0.0
No	Ramp Slope (%)	8.7	N/A	Grade Break XSlope (%)	0.0
Yes	Ramp XSlope (%)	1.2			
N/A	Flare Type LT	N/A	N/A	Flare Type RT	N/A
N/A	Flare Slope LT (%)	N/A	N/A	Flare Slope RT (%)	0.0
N/A	Flare Traversable LT?	N/A	N/A	Flare Traversable RT?	N/A
N/A	Landing Length (in)	0.0	N/A	DWS Provided?	N/A
N/A	Landing Width (in)	0.0	N/A	DWS Contrast?	N/A
N/A	Landing Slope (%)	0.0	N/A	DWS Length (in)	N/A
N/A	Landing X Slope (%)	0.0	N/A	DWS Full Width?	N/A
N/A	Landing Curb? (Y/N)	N/A	N/A	DWS Offset LT (in)	N/A
N/A	Shared Landing?	N/A	N/A	DWS Offset RT (in)	N/A
N/A	Gutter Ponding?	0.0	N/A	Gutter Slope (%)	N/A
N/A	Gutter Lip Ht (in)	0.0	N/A	Gutter X Slope (%)	N/A
N/A	Painted X Walk1?	No		Road Slope (%)	3.1
	X Walk 1 Direction	To SE		Road X Slope (%)	5.0
	X Walk 1 Width (in)	N/A		Clear Space?	N/A

X Walk 1 Slope (%)	3.1	N/A	Clear Space to XWalk (in)	N/A
	X Walk 1 X Slope (%)	5.0	N/A	Storm Grate/Utility Hazard?	N/A
N/A	Ramp inside XWalk1?	N/A		Storm Grate/Utility Type	
N/A	Any Obstructions?	N/A			N/A
	Obstruction Type		Yes	Surface Condition? (G/P)	Good
			N/A	Curb Slope (%)	4.3

Possible Solutions:

Remove & Replace Entire Ramp.
