Access Compliance Report

Public Rights-of-Way

(Curb Ramps)

Intersection ID: 8458	Main Street: BRADFORD_DR	Cross Street: GUM_ST	Location: E
ADA ID: 15F3828D95A4	Ramp Type: Directional1	Initial Pass/Fail: Fail	Overall Compliance: No
Severity Score: 13.75			
Codes/Mitigation Info/Possible Solution		Field Measurements/Component Compliance

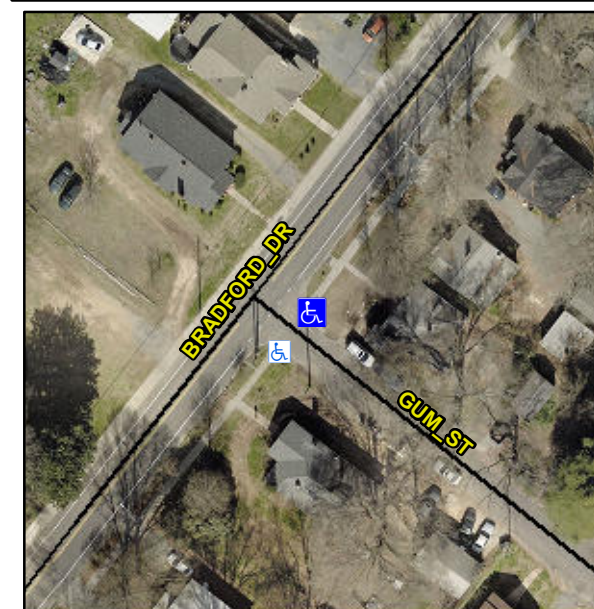
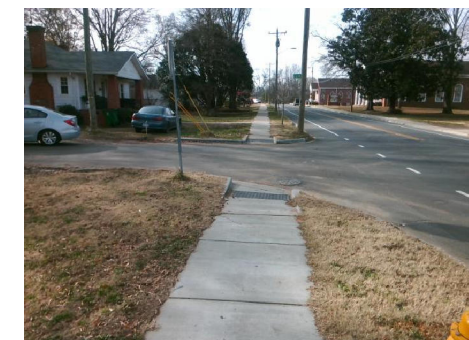
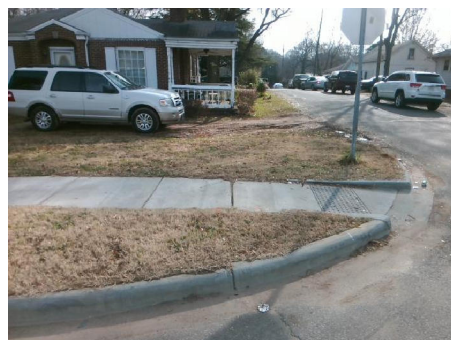
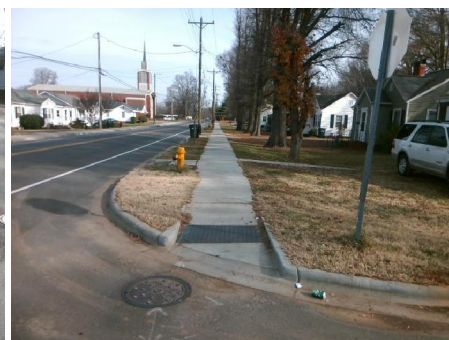
Compliance	Description	Data	Compliance	Description	Data
N/A	Ramp Length (in)	68.0	N/A	Grade Break?	N/A
Yes	Ramp Width (in)	48.0	N/A	Grade Break Slope (%)	0.0
No	Ramp Slope (%)	8.4	N/A	Grade Break XSlope (%)	0.0
No	Ramp XSlope (%)	3.6			
N/A	Flare Type LT	N/A	N/A	Flare Type RT	N/A
N/A	Flare Slope LT (%)	N/A	N/A	Flare Slope RT (%)	0.0
N/A	Flare Traversable LT?	N/A	N/A	Flare Traversable RT?	N/A
N/A	Landing Length (in)	0.0	N/A	DWS Provided?	N/A
N/A	Landing Width (in)	0.0	N/A	DWS Contrast?	N/A
N/A	Landing Slope (%)	0.0	N/A	DWS Length (in)	N/A
N/A	Landing X Slope (%)	0.0	N/A	DWS Full Width?	N/A
N/A	Landing Curb? (Y/N)	N/A	N/A	DWS Offset LT (in)	N/A
N/A	Shared Landing?	N/A	N/A	DWS Offset RT (in)	N/A
N/A	Gutter Ponding?	0.0	N/A	Gutter Slope (%)	N/A
N/A	Gutter Lip Ht (in)	0.0	N/A	Gutter X Slope (%)	N/A
N/A	Painted X Walk1?	No		Road Slope (%)	0.4
	X Walk 1 Direction	To SW		Road X Slope (%)	0.1
	X Walk 1 Width (in)	N/A		Clear Space?	N/A

X Walk 1 Slope (%)	0.4	N/A	Clear Space to XWalk (in)	N/A
	X Walk 1 X Slope (%)	0.1	N/A	Storm Grate/Utility Hazard?	N/A
N/A	Ramp inside XWalk1?	N/A		Storm Grate/Utility Type	
N/A	Any Obstructions?	N/A			N/A
	Obstruction Type		Yes	Surface Condition? (G/P)	Good
			N/A	Curb Slope (%)	10.7

Possible Solutions:

Remove & Replace Entire Ramp.

R304.2.2, R304.5.3
