Access Compliance Report

Public Rights-of-Way

(Curb Ramps)

Intersection ID: 10033476	Main Street: OLD_PINEVILLE_RD	Cross Street: BARTON_BV	Location: SW
ADA ID: 15F758EEBF18	Ramp Type: Directional1	Initial Pass/Fail: Pass	Overall Compliance: No
Severity Score: 2.75			
Codes/Mitigation Info/Possible Solution		Field Measurements/Component Compliance

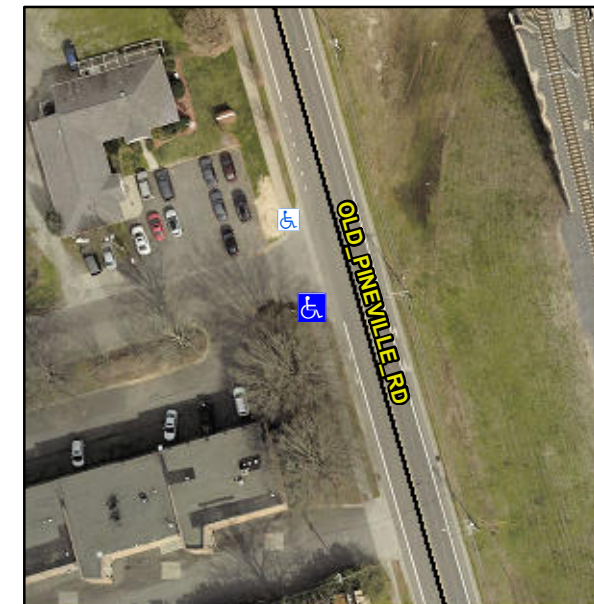
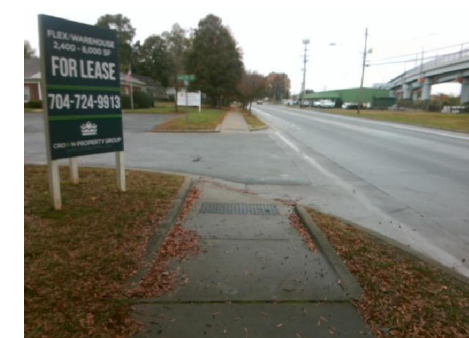
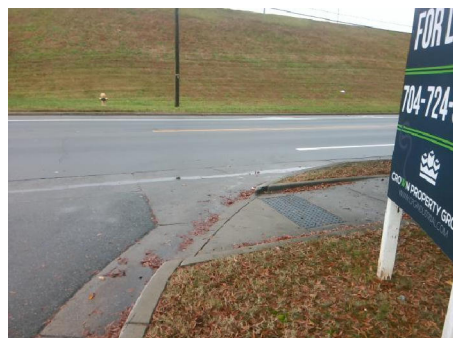
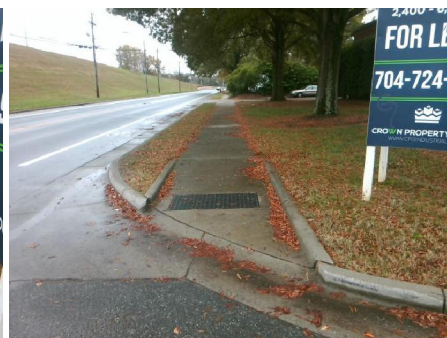
Not Found, R305.1.4, R305.2

Compliance	Description	Data	Compliance	Description	Data
N/A	Ramp Length (in)	112.5	Yes	Grade Break?	Yes
Yes	Ramp Width (in)	69.0	Yes	Grade Break Slope (%)	2.0
Yes	Ramp Slope (%)	2.6	Yes	Grade Break XSlope (%)	2.9
Yes	Ramp XSlope (%)	3.2			
Yes	Flare Type LT	N/A	Yes	Flare Type RT	N/A
N/A	Flare Slope LT (%)	N/A	N/A	Flare Slope RT (%)	N/A
N/A	Flare Traversable LT?	No	N/A	Flare Traversable RT?	No
Yes	Landing Length (in)	58.0	Yes	DWS Provided?	Yes
Yes	Landing Width (in)	75.0	Yes	DWS Contrast?	Yes
Yes	Landing Slope (%)	1.5	Yes	DWS Length (in)	24.0
Yes	Landing X Slope (%)	2.8	No	DWS Full Width?	No
N/A	Landing Curb? (Y/N)	No	No	DWS Offset LT (in)	5.0
N/A	Shared Landing?	No	Yes	DWS Offset RT (in)	51.0
Yes	Gutter Ponding?	No	Yes	Gutter Slope (%)	0.0
Yes	Gutter Lip Ht (in)	0.0	Yes	Gutter X Slope (%)	2.8
N/A	Painted X Walk1?	No		Road Slope (%)	0.0
	X Walk 1 Direction	To N		Road X Slope (%)	3.3
	X Walk 1 Width (in)	N/A		Clear Space?	Yes

X Walk 1 Slope (%)	0.0	N/A	Clear Space to XWalk (in)	N/A
	X Walk 1 X Slope (%)	3.3	Yes	Storm Grate/Utility Hazard?	No
N/A	Ramp inside XWalk1?	N/A		Storm Grate/Utility Type	
Yes	Any Obstructions?	No			N/A
	Obstruction Type		Yes	Surface Condition? (G/P)	Good
			N/A	Curb Slope (%)	17.3

Remove & Replace Entire Ramp.
