Access Compliance Report

Public Rights-of-Way

(Curb Ramps)

Intersection ID: 21411	Main Street: MONROE_RD	Cross Street: SARDIS_RD_NORTH	Location: SE
ADA ID: 15F81E89B28F	Ramp Type: Combination1	Initial Pass/Fail: Fail	Overall Compliance: No
		Severity Score: 22.5

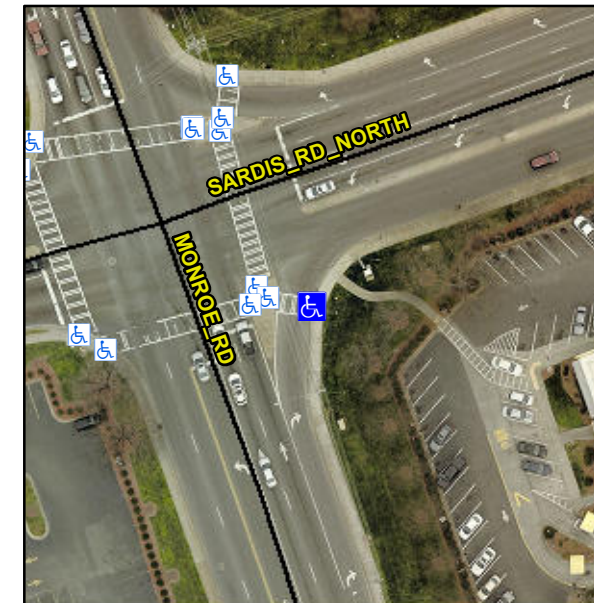
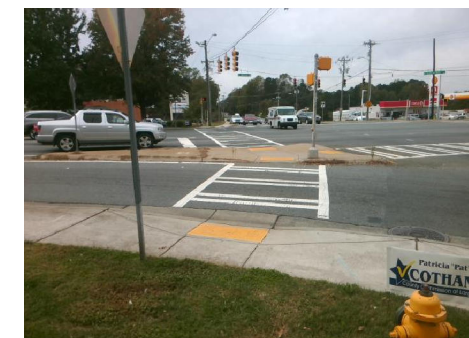
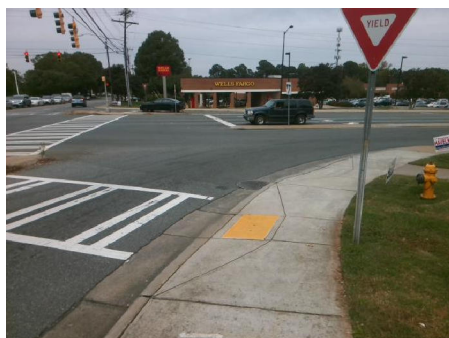
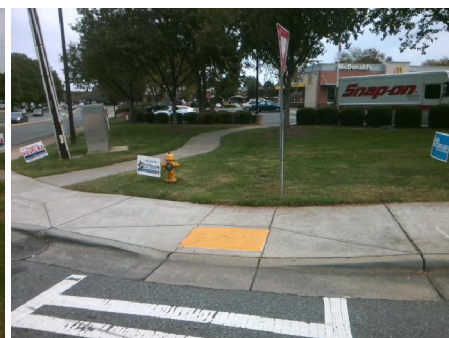
LT RP < 5%

**Not Found, R304.5.1, R304.5.1,
R304.2.2, R304.5.3, R304.3.2**

Compliance	Description	Data	Compliance	Description	Data
N/A	Ramp Length LT (in)	76.0	N/A	Ramp Length RT (in)	68.0
No	Ramp Width LT (in)	36.0	No	Ramp Width RT (in)	36.0
Yes	Ramp Slope LT (%)	1.0	No	Ramp Slope RT (%)	10.2
No	Ramp XSlope LT (%)	3.6	No	Ramp XSlope RT (%)	4.8
N/A	Ramp Length (in)	35.0	No	Ramp Slope (%)	8.6
No	Ramp Width (in)	44.5	No	Ramp XSlope (%)	5.0
N/A	Flare Type LT	N/A	N/A	Flare Type RT	N/A
N/A	Flare Slope LT (%)	N/A	N/A	Flare Slope RT (%)	N/A
N/A	Flare Traversable LT?	N/A	N/A	Flare Traversable RT?	N/A
N/A	Landing Length (in)	N/A	N/A	DWS Provided?	N/A
N/A	Landing Width (in)	N/A	N/A	DWS Contrast?	N/A
N/A	Landing Slope (%)	N/A	N/A	DWS Length (in)	N/A
N/A	Landing X Slope (%)	N/A	N/A	DWS Full Width?	N/A
N/A	Landing Curb? (Y/N)	N/A	N/A	DWS Offset (in)	N/A
N/A	Shared Landing?	N/A			
N/A	Gutter Ponding?	N/A	N/A	Gutter Slope (%)	N/A
N/A	Gutter Lip Ht (in)	N/A	N/A	Gutter X Slope (%)	N/A
N/A	Painted X Walk1?	Yes	N/A	Painted X Walk2?	N/A

Remove & Replace Entire Ramp.
