Access Compliance Report

Public Rights-of-Way

(Curb Ramps)

Intersection ID: 10025384	Main Street: E_9TH_ST	Cross Street: N/A	Location: SW
ADA ID: 1612C06BF63A	Ramp Type: Perp	Initial Pass/Fail: Fail	Overall Compliance: No
Severity Score: 8.75			
Codes/Mitigation Info/Possible Solution		Field Measurements/Component Compliance

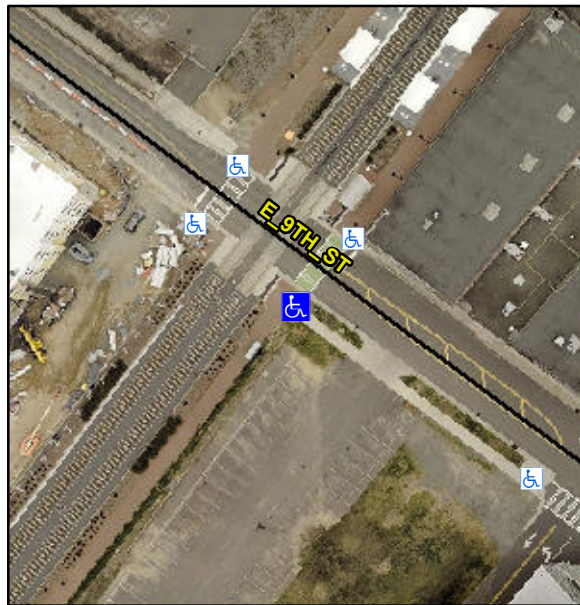
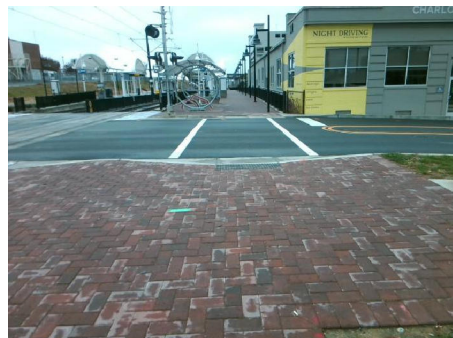
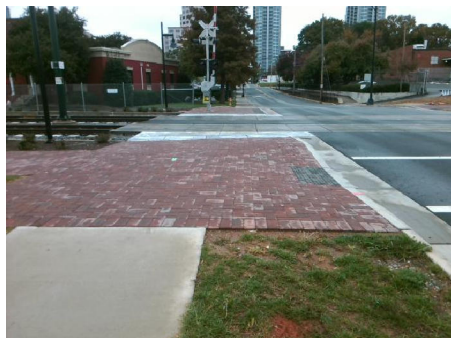
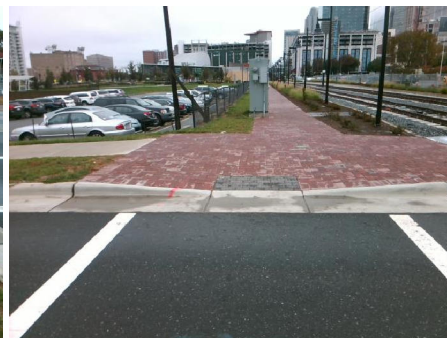
Not Found, R304.5.1

Compliance	Description	Data	Compliance	Description	Data
N/A	Ramp Length (in)	70.0	Yes	Ramp Slope (%)	6.3
No	Ramp Width (in)	47.0	Yes	Ramp XSlope (%)	0.4
N/A	Flare Type LT	N/A	N/A	Flare Type RT	N/A
N/A	Flare Slope LT (%)	N/A	N/A	Flare Slope RT (%)	N/A
N/A	Flare Traversable LT?	N/A	N/A	Flare Traversable RT?	N/A
N/A	Landing Length (in)	N/A	N/A	DWS Provided?	N/A
N/A	Landing Width (in)	N/A	N/A	DWS Contrast?	N/A
N/A	Landing Slope (%)	N/A	N/A	DWS Length (in)	N/A
N/A	Landing X Slope (%)	N/A	N/A	DWS Full Width?	N/A
N/A	Landing Curb? (Y/N)	N/A	N/A	DWS Offset (in)	N/A
N/A	Shared Landing?	N/A			
N/A	Gutter Ponding?	N/A	N/A	Gutter Slope (%)	N/A
N/A	Gutter Lip Ht (in)	N/A	N/A	Gutter X Slope (%)	N/A
N/A	Painted X Walk1?	Yes	N/A	Painted X Walk2?	N/A
	X Walk 1 Direction	To NE		X Walk 2 Direction	N/A
N/A	X Walk 1 Width (in)	111.0	N/A	X Walk 2 Width (in)	N/A
	X Walk 1 Slope (%)	0.2		X Walk 2 Slope (%)	N/A
	X Walk 1 X Slope (%)	1.0		X Walk 2 X Slope (%)	N/A

N/A	Ramp inside XWalk1?	Yes	N/A	Ramp inside XWalk2?	N/A
	Road Slope (%)	N/A	N/A	Clear Space?	N/A
	Road X Slope (%)	N/A	N/A	Clear Space to XWalk (in)	N/A
N/A	Any Obstructions?	N/A	N/A	Storm Grate/Utility Hazard?	N/A
	Obstruction Type			Storm Grate/Utility Type	
		N/A			N/A
			Yes	Surface Condition? (G/P)	Good

Possible Solutions:

Remove & Replace Entire Ramp.
