Access Compliance Report Public Rights-of-Way (Curb Ramps)

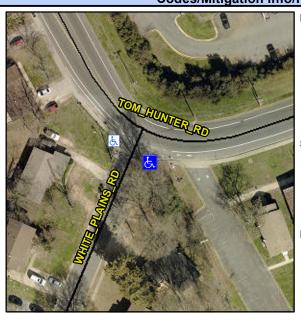
Surveyor Notes:

RT RP < 5%

Field Measurements/Component Compliance					
Compliance Description		Data	Compliance Description		Data
N/A	Ramp Length LT (in)	63.0	N/A	Ramp Length RT (in)	49.0
Yes	Ramp Width LT (in)	53.0	Yes	Ramp Width RT (in)	61.0
Yes	Ramp Slope LT (%)	6.6	Yes	Ramp Slope RT (%)	2.9
No	Ramp XSlope LT (%)	3.9	No	Ramp XSlope RT (%)	2.9
N/A	Landing Length (in)	N/A	N/A	DWS Provided?	N/A
N/A	Landing Width (in)	N/A	N/A	DWS Contrast?	N/A
N/A	Landing Slope (%)	N/A	N/A	DWS Length (in)	N/A
N/A	Landing X Slope (%)	N/A	N/A	DWS Full Width?	N/A
N/A	Landing Curb? (Y/N)	N/A	N/A	DWS Offset (in)	N/A
N/A	Shared Landing?	N/A			
N/A	Gutter Ponding?	N/A	N/A	Gutter Slope (%)	N/A
N/A	Gutter Lip Ht (in)	N/A	N/A	Gutter X Slope (%)	N/A
N/A	Painted X Walk1?	No	N/A	Painted X Walk2?	N/A
	X Walk 1 Direction	To W		X Walk 2 Direction	N/A
N/A	X Walk 1 Width (in)	N/A	N/A	X Walk 2 Width (in)	N/A
	X Walk 1 Slope (%)	0.0		X Walk 2 Slope (%)	N/A
	X Walk 1 X Slope (%)	2.9		X Walk 2 X Slope (%)	N/A

Possible Solutions:

Remove & Replace Entire Ramp.
