Access Compliance Report

Public Rights-of-Way

(Curb Ramps)

Intersection ID: 7836	Main Street: SNOW_WHITE_LN	Cross Street: SPRING_GARDEN_LN	Location: SW
ADA ID: 1621508C66CC	Ramp Type: Perp	Initial Pass/Fail: Fail	Overall Compliance: No
Codes/Mitigation Info/Possible Solution		Field Measurements/Component Compliance	
Severity Score: 10

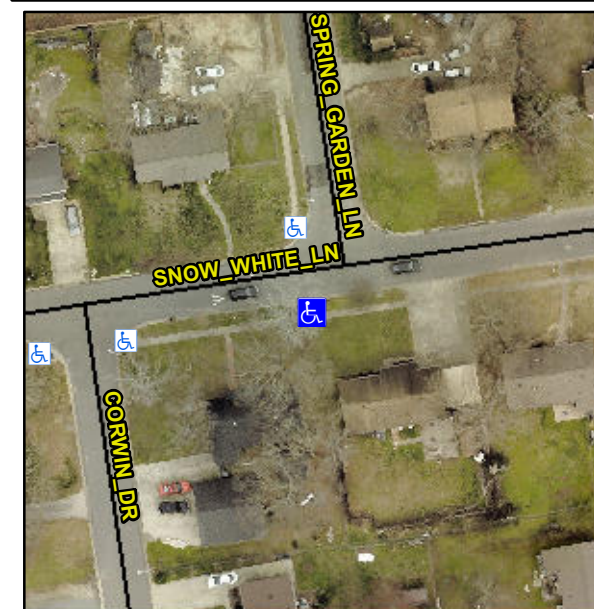
Not Found, R304.5.1

Compliance	Description	Data	Compliance	Description	Data
N/A	Ramp Length (in)	79.0	Yes	Ramp Slope (%)	5.1
No	Ramp Width (in)	44.5	Yes	Ramp XSlope (%)	2.7
N/A	Flare Type LT	N/A	N/A	Flare Type RT	N/A
N/A	Flare Slope LT (%)	N/A	N/A	Flare Slope RT (%)	N/A
N/A	Flare Traversable LT?	N/A	N/A	Flare Traversable RT?	N/A
N/A	Landing Length (in)	N/A	N/A	DWS Provided?	N/A
N/A	Landing Width (in)	N/A	N/A	DWS Contrast?	N/A
N/A	Landing Slope (%)	N/A	N/A	DWS Length (in)	N/A
N/A	Landing X Slope (%)	N/A	N/A	DWS Full Width?	N/A
N/A	Landing Curb? (Y/N)	N/A	N/A	DWS Offset (in)	N/A
N/A	Shared Landing?	N/A			
N/A	Gutter Ponding?	N/A	N/A	Gutter Slope (%)	N/A
N/A	Gutter Lip Ht (in)	N/A	N/A	Gutter X Slope (%)	N/A
N/A	Painted X Walk1?	No	N/A	Painted X Walk2?	N/A
	X Walk 1 Direction	To N		X Walk 2 Direction	N/A
N/A	X Walk 1 Width (in)	N/A	N/A	X Walk 2 Width (in)	N/A
	X Walk 1 Slope (%)	4.6		X Walk 2 Slope (%)	N/A
	X Walk 1 X Slope (%)	3.8		X Walk 2 X Slope (%)	N/A

N/A	Ramp inside XWalk1?	N/A	N/A	Ramp inside XWalk2?	N/A
	Road Slope (%)	N/A	N/A	Clear Space?	N/A
	Road X Slope (%)	N/A	N/A	Clear Space to XWalk (in)	N/A
N/A	Any Obstructions?	N/A	N/A	Storm Grate/Utility Hazard?	N/A
	Obstruction Type			Storm Grate/Utility Type	
		N/A			N/A
			Yes	Surface Condition? (G/P)	Good

Possible Solutions:

Remove & Replace Entire Ramp.
