# Access Compliance Report

## Public Rights-of-Way

### (Curb Ramps)

| ADA ID: 16372EDB3D10 | Ramp Type: BlendTrans1 | Initial Pass/Fail: Pass | Overall Compliance: No | Severity Score: 5 |

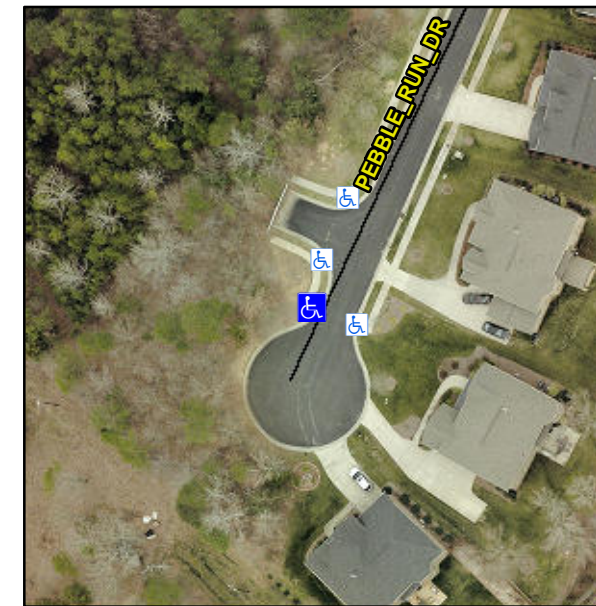
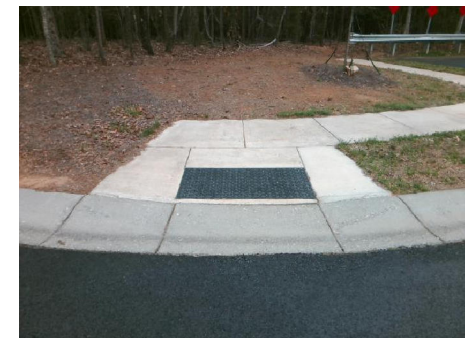
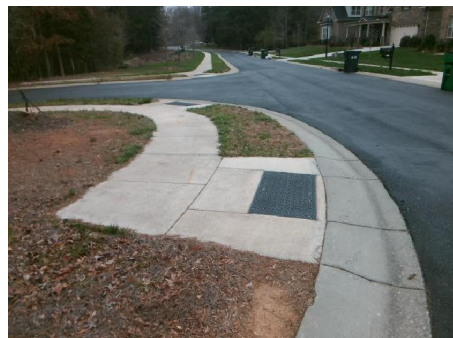
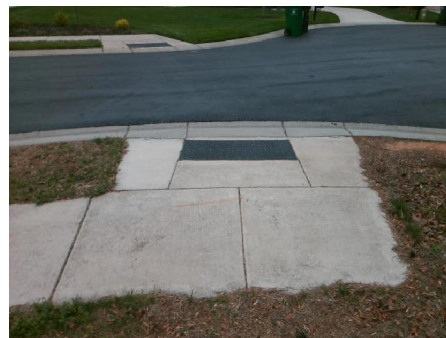
**Not Found, R305.2, R304.5.4**

| Compliance | Description | Data | Compliance | Description | Data |
|---|---|---|---|---|---|
| N/A | Landing Curb? (Y/N) | No | No | DWS Offset (in) | 4.0 |
| Yes | Gutter Ponding? | No | No | Gutter Slope (%) | 10.7 |
| | | | No | Curb Slope (%) | 11.3 |

**Remove & Replace Curb Ramp With Two New Directional Ramps or Equivalent. Remove & Replace Gutter.**

Total Cost: \$ 3950.00
