# Access Compliance Report

## Public Rights-of-Way

| Intersection ID: 30677 | Main Street: DIXIE_HILLS_DR | Cross Street: MARVIN_RD | Location: W |
| ADA ID: 163E613C29E9 | Ramp Type: BlendTrans1 | Initial Pass/Fail: Fail | Overall Compliance: No |

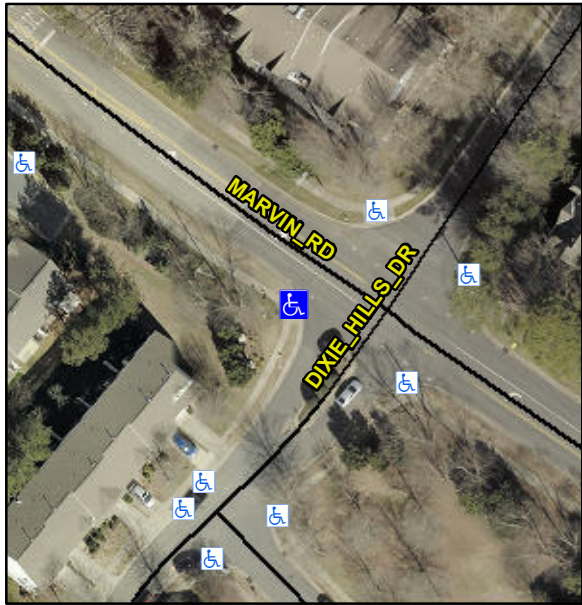
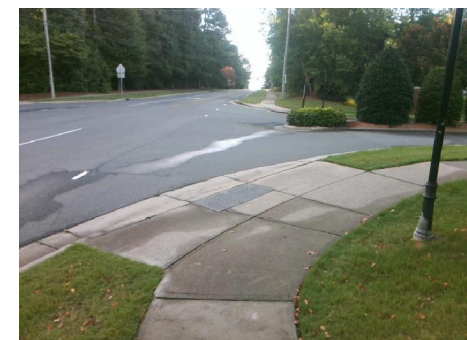
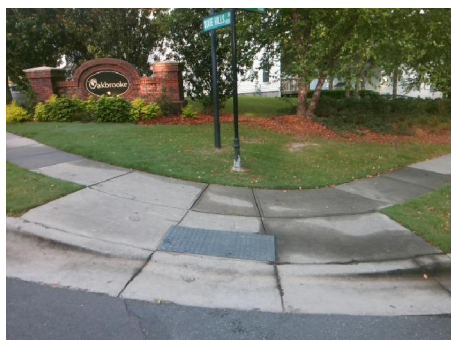
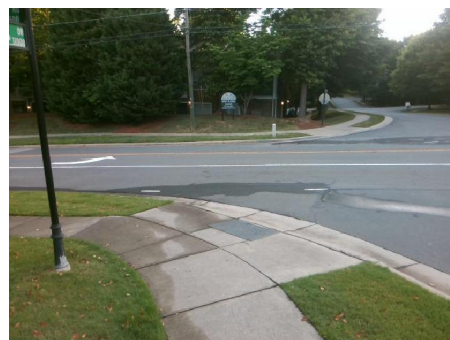
| Codes/Mitigation Info/Possible Solution | | | Field Measurements/Component Compliance | | | | | |
|---|---|---|---|---|---|---|---|---|
| | | | No | Ramp Width (in) | 38.0 | No | BlendTrans XSlope (%) | 11.6 |
| PROW/ADA:<br><br>Not Found, R304.5.1, R304.5.3 | | | | Road Slope (%) | 6.7 | | Clear Space? | N/A |
| | | | | | | No | Curb Slope (%) | 12.7 |

| Codes/Mitigation Info/Possible Solution | | | Field Measurements/Component Compliance | | | | | |
|---|---|---|---|---|---|---|---|---|
| | Remove & Replace Curb Ramp With Two New Directional Ramps or Equivalent. | | N/A | Ramp Length (in) | 46.0 | Yes | BlendTrans Slope (%) | 3.0 |
