# Access Compliance Report

## Public Rights-of-Way

### (Curb Ramps)

| Intersection ID: 18755 | Main Street: MATADOR_LN | Cross Street: SELWYN_AV | Location: W |

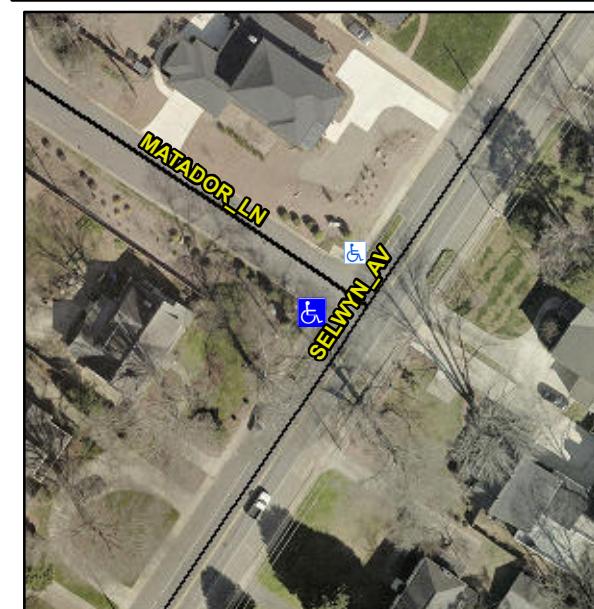
**LT RP < 5%**

**R304.3.2, R304.5.3**

| Compliance | Description | Data | Compliance | Description | Data |
|---|---|---|---|---|---|
| Yes | Ramp Slope LT (%) | 2.3 | No | Ramp Slope RT (%) | 11.4 |
| Yes | Ramp XSlope LT (%) | 1.4 | No | Ramp XSlope RT (%) | 2.6 |

**Remove & Replace Entire Ramp.**
