Access Compliance Report

Public Rights-of-Way

(Curb Ramps)

Intersection ID: N/A	Main Street: ALLEGIANCE DR	Cross Street: LADY LIBERTY LN	Location: SW
ADA ID: 16567E5B06DE	Ramp Type: Perp	Initial Pass/Fail: Fail	Overall Compliance: No
		Severity Score: 12.5

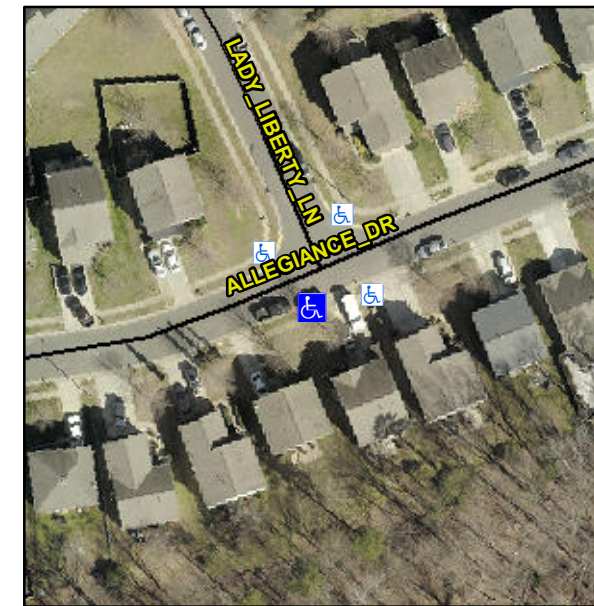
Not Found, R304.2.2

Compliance	Description	Data	Compliance	Description	Data
N/A	Ramp Length (in)	48.0	No	Ramp Slope (%)	8.7
Yes	Ramp Width (in)	52.5	Yes	Ramp XSlope (%)	2.0
N/A	Flare Type LT	N/A	N/A	Flare Type RT	N/A
N/A	Flare Slope LT (%)	N/A	N/A	Flare Slope RT (%)	N/A
N/A	Flare Traversable LT?	No	N/A	Flare Traversable RT?	No
N/A	Landing Length (in)	N/A	N/A	DWS Provided?	N/A
N/A	Landing Width (in)	N/A	N/A	DWS Contrast?	N/A
N/A	Landing Slope (%)	N/A	N/A	DWS Length (in)	N/A
N/A	Landing X Slope (%)	N/A	N/A	DWS Full Width?	N/A
N/A	Landing Curb? (Y/N)	N/A	N/A	DWS Offset (in)	N/A
N/A	Shared Landing?	N/A			
N/A	Gutter Ponding?	N/A	N/A	Gutter Slope (%)	N/A
N/A	Gutter Lip Ht (in)	N/A	N/A	Gutter X Slope (%)	N/A
N/A	Painted X Walk1?	No	N/A	Painted X Walk2?	N/A
	X Walk 1 Direction	To N		X Walk 2 Direction	N/A
N/A	X Walk 1 Width (in)	N/A	N/A	X Walk 2 Width (in)	N/A
	X Walk 1 Slope (%)	5.5		X Walk 2 Slope (%)	N/A
	X Walk 1 X Slope (%)	0.1		X Walk 2 X Slope (%)	N/A

N/A	Ramp inside XWalk1?	No	N/A	Ramp inside XWalk2?	N/A
	Road Slope (%)	N/A	N/A	Clear Space?	N/A
	Road X Slope (%)	N/A	N/A	Clear Space to XWalk (in)	N/A
N/A	Any Obstructions?	N/A	N/A	Storm Grate/Utility Hazard?	N/A
	Obstruction Type			Storm Grate/Utility Type	
		N/A			N/A
			Yes	Surface Condition? (G/P)	Good

Possible Solutions:

Remove & Replace Entire Ramp.
