# Access Compliance Report

## Public Rights-of-Way

| Intersection ID: 28763 | Main Street: CAMBRIDGE_COMMONS_DR | Cross Street: GREATFORD_CT | Location: SE |
| ADA ID: 165AD246C966 | Ramp Type: BlendTrans1 | Initial Pass/Fail: Fail | Overall Compliance: No |

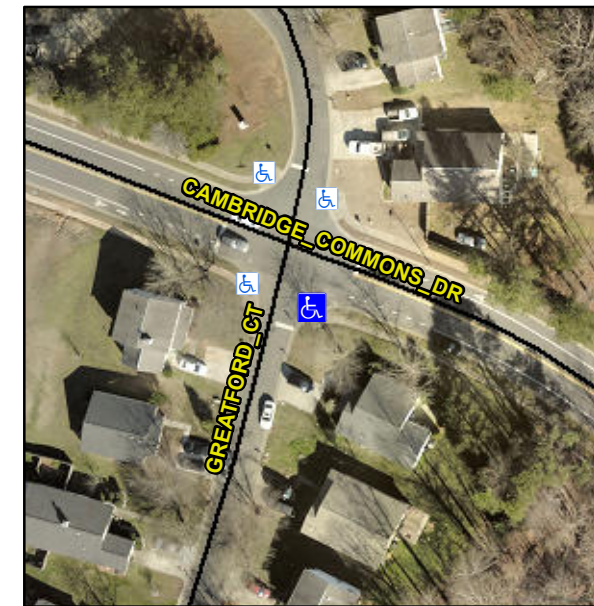
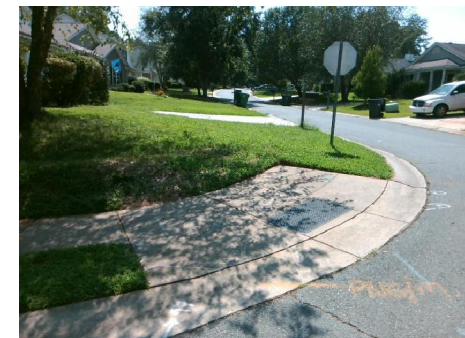
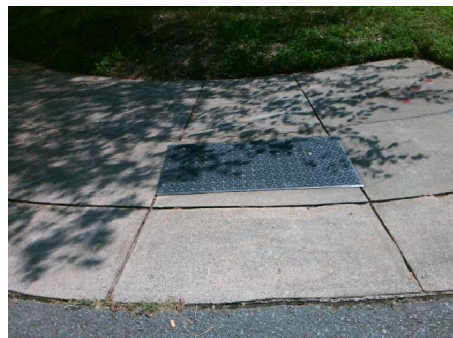
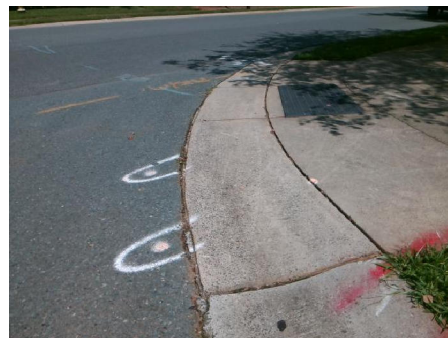
**NO RT SW**

**R304.5.1, R304.5.3**

| Compliance | Description | Data | Compliance | Description | Data |
|---|---|---|---|---|---|
| No | Ramp Width (in) | 43.0 | No | BlendTrans XSlope (%) | 6.6 |

**Remove & Replace Curb Ramp With Two New Directional Ramps or Equivalent.**

Total Cost: \$ 3200.00
