# Access Compliance Report

## Public Rights-of-Way

### (Curb Ramps)

| Intersection ID: 26562 | Main Street: KIELDON_CT | Cross Street: SETON_HOUSE_LN | Location: N |

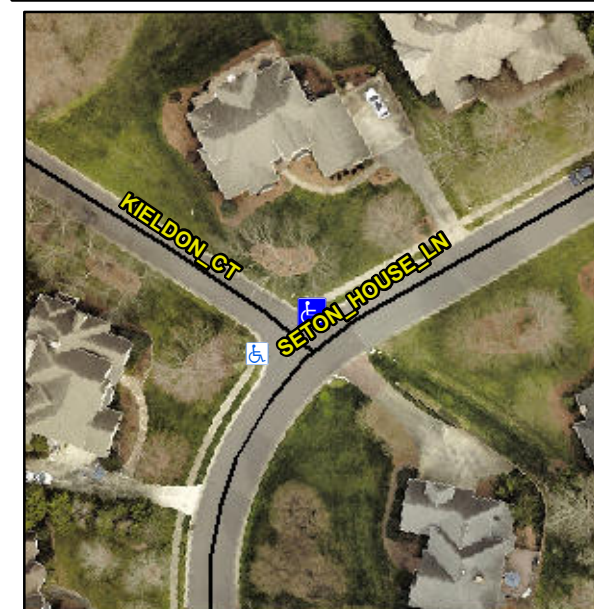
| ADA ID: 165B67D925BC | Ramp Type: PerpDiag | Initial Pass/Fail: Fail | Overall Compliance: No |
| Severity Score: 33.75 | | | |

**R304.5.1, R304.2.2, R304.5.3**

| Compliance | Description | Data | Compliance | Description | Data |
|---|---|---|---|---|---|
| N/A | Ramp Length (in) | 97.0 | No | Ramp Slope (%) | 10.1 |
| No | Ramp Width (in) | 47.0 | No | Ramp XSlope (%) | 5.4 |

**Remove & Replace Curb Ramp With Two New Directional Ramps or Equivalent.**
