# Access Compliance Report

## Public Rights-of-Way

### (Curb Ramps)

Intersection ID: 53018	Main Street: STEEL_HOUSE_BV	Cross Street: SPENCER_ST	Location: NW
ADA ID: 165BEC9A2831	Ramp Type: BlendTrans2	Initial Pass/Fail: Pass	Overall Compliance: No
Codes/Mitigation Info/Possible Solution		Field Measurements/Component Compliance	
Severity Score: 17.5

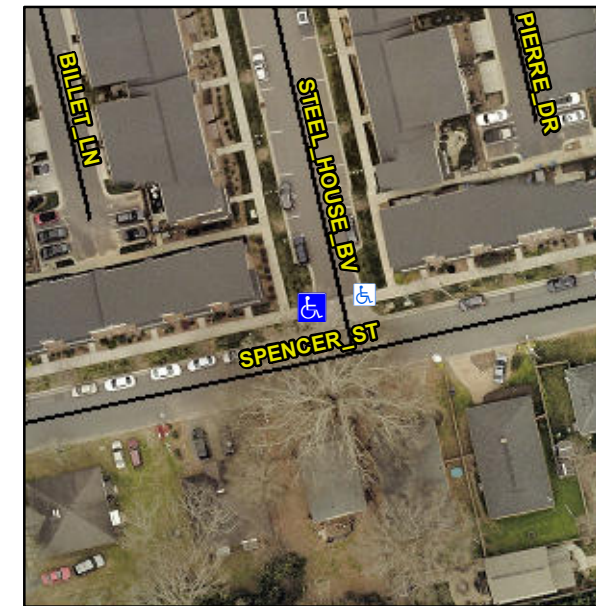
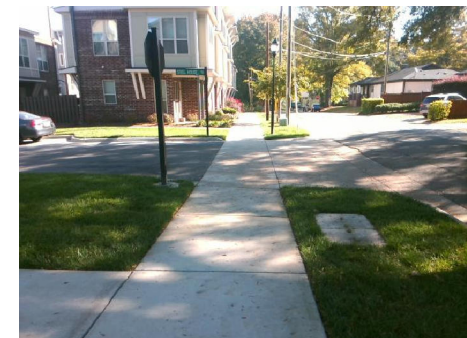
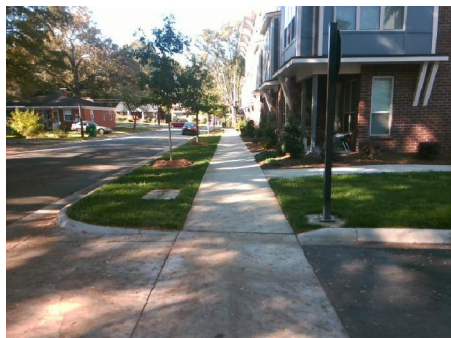
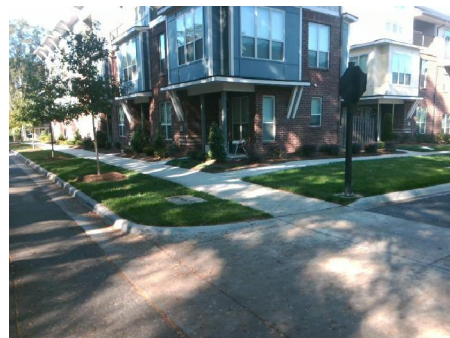
Compliance	Description	Data	Compliance	Description	Data
N/A	Ramp Length (in)	72.5	Yes	BlendTrans Slope (%)	1.7
Yes	Ramp Width (in)	71.0	Yes	BlendTrans XSlope (%)	1.6
N/A	Flare Type LT	None	N/A	Flare Type RT	None
N/A	Flare Slope LT (%)	N/A	N/A	Flare Slope RT (%)	N/A
N/A	Flare Traversable LT?	N/A	N/A	Flare Traversable RT?	N/A
N/A	Landing Length (in)	N/A	No	DWS Provided?	No
N/A	Landing Width (in)	N/A	N/A	DWS Contrast?	No
N/A	Landing Slope (%)	N/A	N/A	DWS Length (in)	N/A
N/A	Landing X Slope (%)	N/A	N/A	DWS Full Width?	No
N/A	Landing Curb? (Y/N)	No	N/A	DWS Offset (in)	N/A
N/A	Shared Landing?	No			
Yes	Gutter Ponding?	No	Yes	Gutter Slope (%)	0.9
No	Gutter Lip Ht (in)	0.5	Yes	Gutter X Slope (%)	0.5
N/A	Painted X Walk1?	No	N/A	Painted X Walk2?	N/A
	X Walk 1 Direction	To E		X Walk 2 Direction	N/A
	X Walk 1 Width (in)	N/A		X Walk 2 Width (in)	N/A
	X Walk 1 Slope (%)	0.7		X Walk 2 Slope (%)	N/A
	X Walk 1 X Slope (%)	0.5		X Walk 2 X Slope (%)	N/A

N/A	Ramp inside XWalk1?	N/A	N/A	Ramp inside XWalk2?	N/A
	Road Slope (%)	0.5		Clear Space?	Yes
	Road X Slope (%)	0.7	N/A	Clear Space to XWalk (in)	N/A
Yes	Any Obstructions?	No	Yes	Storm Grate/Utility Hazard?	No
	Obstruction Type			Storm Grate/Utility Type	
		N/A			N/A
			Yes	Surface Condition? (G/P)	Good
			Yes	Curb Slope (%)	0.4

**Install Detectable Warning System.  
Grind Gutter Lip.**

**R305, R302.7.2**
