Access Compliance Report

Public Rights-of-Way

(Curb Ramps)

Intersection ID: 21804	Main Street: NOLLEY_CT	Cross Street: GALLERIA_BV	Location: NE
ADA ID: 165FE0C6EAD2	Ramp Type: Perp	Initial Pass/Fail: Fail	Overall Compliance: No
		Severity Score: 12.5

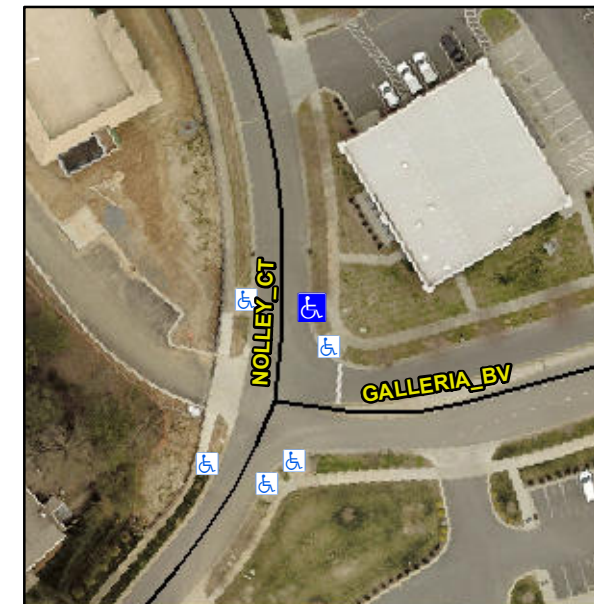
R304.2.2

Compliance	Description	Data	Compliance	Description	Data
N/A	Ramp Length (in)	94.0	No	Ramp Slope (%)	8.5
Yes	Ramp Width (in)	48.0	Yes	Ramp XSlope (%)	0.6
N/A	Flare Type LT	N/A	N/A	Flare Type RT	N/A
N/A	Flare Slope LT (%)	N/A	N/A	Flare Slope RT (%)	N/A
N/A	Flare Traversable LT?	N/A	N/A	Flare Traversable RT?	N/A
N/A	Landing Length (in)	N/A	N/A	DWS Provided?	N/A
N/A	Landing Width (in)	N/A	N/A	DWS Contrast?	N/A
N/A	Landing Slope (%)	N/A	N/A	DWS Length (in)	N/A
N/A	Landing X Slope (%)	N/A	N/A	DWS Full Width?	N/A
N/A	Landing Curb? (Y/N)	N/A	N/A	DWS Offset (in)	N/A
N/A	Shared Landing?	N/A			
N/A	Gutter Ponding?	N/A	N/A	Gutter Slope (%)	N/A
N/A	Gutter Lip Ht (in)	N/A	N/A	Gutter X Slope (%)	N/A
N/A	Painted X Walk1?	No	N/A	Painted X Walk2?	N/A
	X Walk 1 Direction	To NW		X Walk 2 Direction	N/A
N/A	X Walk 1 Width (in)	N/A	N/A	X Walk 2 Width (in)	N/A
	X Walk 1 Slope (%)	1.4		X Walk 2 Slope (%)	N/A
	X Walk 1 X Slope (%)	0.2		X Walk 2 X Slope (%)	N/A

Remove & Replace Entire Ramp.
