# Access Compliance Report

## Public Rights-of-Way

### (Curb Ramps)

Intersection ID: 27900	Main Street: FROHOCK_PL	Cross Street: HARRISON'S_CROSSING_AV	Location: SE
ADA ID: 166DCC12700A	Ramp Type: BlendTrans2	Initial Pass/Fail: Fail	Overall Compliance: No
		Severity Score: 10

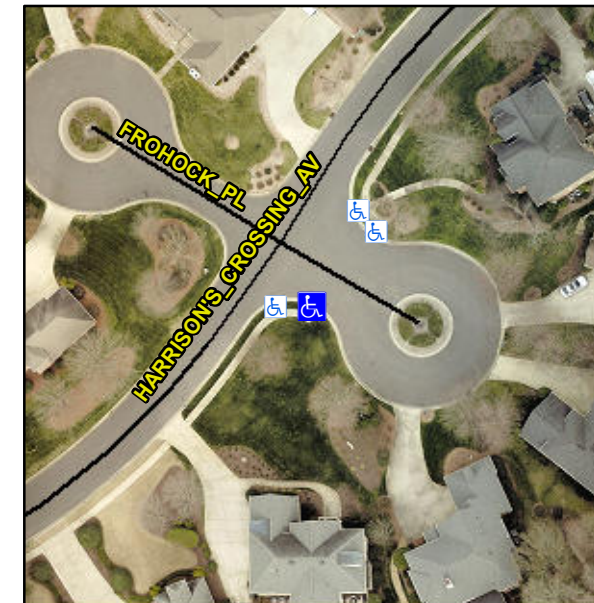
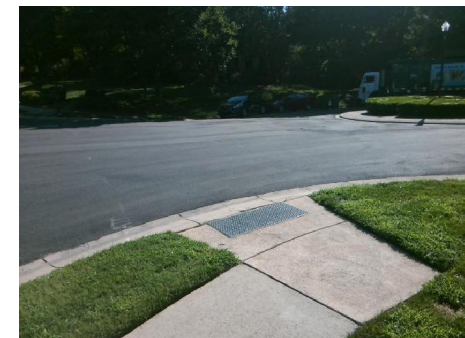
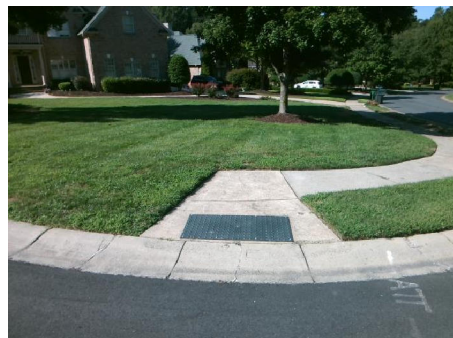
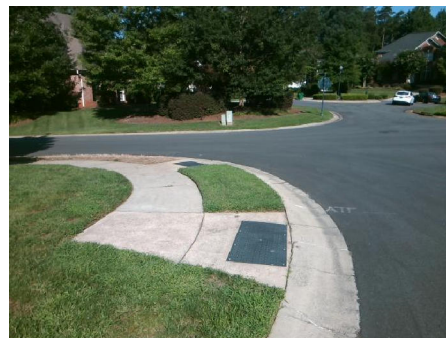
**Not Found, R304.5.1, R304.5.3**

Compliance	Description	Data	Compliance	Description	Data
N/A	Ramp Length (in)	98.0	Yes	BlendTrans Slope (%)	1.6
No	Ramp Width (in)	44.0	No	BlendTrans XSlope (%)	2.5
N/A	Flare Type LT	N/A	N/A	Flare Type RT	N/A
N/A	Flare Slope LT (%)	N/A	N/A	Flare Slope RT (%)	N/A
N/A	Flare Traversable LT?	N/A	N/A	Flare Traversable RT?	N/A
N/A	Landing Length (in)	N/A	N/A	DWS Provided?	N/A
N/A	Landing Width (in)	N/A	N/A	DWS Contrast?	N/A
N/A	Landing Slope (%)	N/A	N/A	DWS Length (in)	N/A
N/A	Landing X Slope (%)	N/A	N/A	DWS Full Width?	N/A
N/A	Landing Curb? (Y/N)	N/A	N/A	DWS Offset (in)	N/A
N/A	Shared Landing?	N/A			
N/A	Gutter Ponding?	N/A	N/A	Gutter Slope (%)	N/A
N/A	Gutter Lip Ht (in)	N/A	N/A	Gutter X Slope (%)	N/A
N/A	Painted X Walk1?	No	N/A	Painted X Walk2?	N/A
	X Walk 1 Direction	To NE		X Walk 2 Direction	N/A
	X Walk 1 Width (in)	N/A		X Walk 2 Width (in)	N/A
	X Walk 1 Slope (%)	4.4		X Walk 2 Slope (%)	N/A
	X Walk 1 X Slope (%)	0.9		X Walk 2 X Slope (%)	N/A

N/A	Ramp inside XWalk1?	N/A	N/A	Ramp inside XWalk2?	N/A
	Road Slope (%)	0.9		Clear Space?	N/A
	Road X Slope (%)	4.4	N/A	Clear Space to XWalk (in)	N/A
N/A	Any Obstructions?	N/A	N/A	Storm Grate/Utility Hazard?	N/A
	Obstruction Type			Storm Grate/Utility Type	
		N/A			N/A
			Yes	Surface Condition? (G/P)	Good
			No	Curb Slope (%)	9.8

**Remove & Replace Curb Ramp With Two New Directional Ramps or Equivalent.**
