Access Compliance Report

Public Rights-of-Way

(Curb Ramps)

Intersection ID: 11625	Main Street: E_11TH_ST	Cross Street: N_COLLEGE_ST	Location: S
ADA ID: 167BEFF02C4D	Ramp Type: PerpDiag	Initial Pass/Fail: Fail	Overall Compliance: No
			Severity Score: 21.25

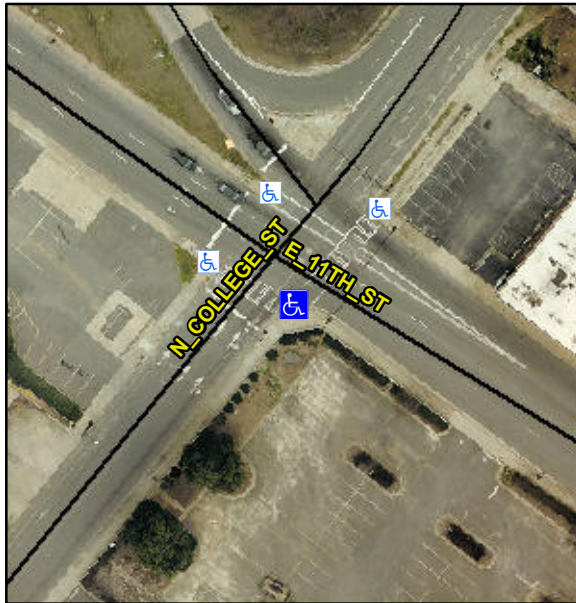
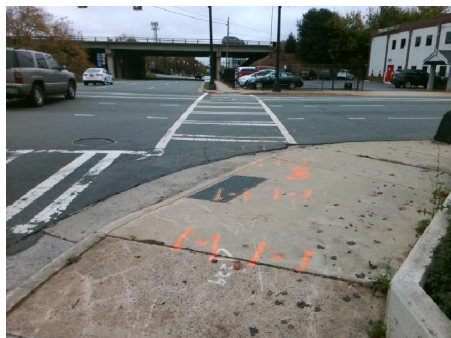
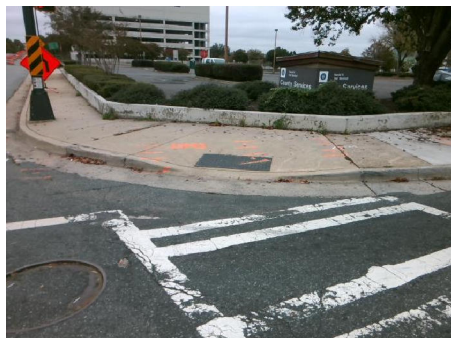
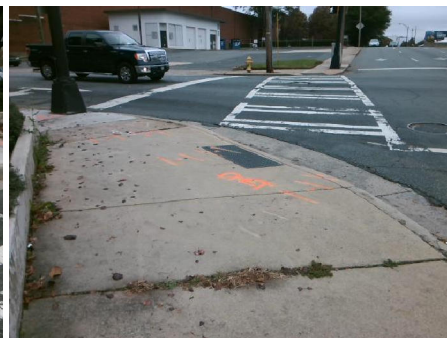
Not Found, R304.5.1, R304.2.2

Compliance	Description	Data	Compliance	Description	Data
N/A	Ramp Length (in)	57.0	No	Ramp Slope (%)	9.7
No	Ramp Width (in)	44.0	Yes	Ramp XSlope (%)	1.3
N/A	Flare Type LT	N/A	N/A	Flare Type RT	N/A
N/A	Flare Slope LT (%)	N/A	N/A	Flare Slope RT (%)	N/A
N/A	Flare Traversable LT?	N/A	N/A	Flare Traversable RT?	N/A
N/A	Landing Length (in)	N/A	N/A	DWS Provided?	N/A
N/A	Landing Width (in)	N/A	N/A	DWS Contrast?	N/A
N/A	Landing Slope (%)	N/A	N/A	DWS Length (in)	N/A
N/A	Landing X Slope (%)	N/A	N/A	DWS Full Width?	N/A
N/A	Landing Curb? (Y/N)	N/A	N/A	DWS Offset (in)	N/A
N/A	Shared Landing?	N/A			
N/A	Gutter Ponding?	N/A	N/A	Gutter Slope (%)	N/A
N/A	Gutter Lip Ht (in)	N/A	N/A	Gutter X Slope (%)	N/A
N/A	Painted X Walk1?	Yes	N/A	Painted X Walk2?	Yes
	X Walk 1 Direction	To NE		X Walk 2 Direction	To NW
N/A	X Walk 1 Width (in)	111.0	N/A	X Walk 2 Width (in)	118.0
	X Walk 1 Slope (%)	1.6		X Walk 2 Slope (%)	7.8
	X Walk 1 X Slope (%)	1.0		X Walk 2 X Slope (%)	2.1

N/A	Ramp inside XWalk1?	Yes	N/A	Ramp inside XWalk2?	Yes
	Road Slope (%)	1.9	N/A	Clear Space?	N/A
	Road X Slope (%)	6.8	N/A	Clear Space to XWalk (in)	N/A
N/A	Any Obstructions?	N/A	N/A	Storm Grate/Utility Hazard?	N/A
	Obstruction Type			Storm Grate/Utility Type	
		N/A			N/A
			Yes	Surface Condition? (G/P)	Good

Remove & Replace Curb Ramp With Two New Directional Ramps or Equivalent.
