# Access Compliance Report

## Public Rights-of-Way

### (Curb Ramps)

| Intersection ID: 11025 | Main Street: CAMP_GREENE_ST | Cross Street: ELON_ST | Location: NW |

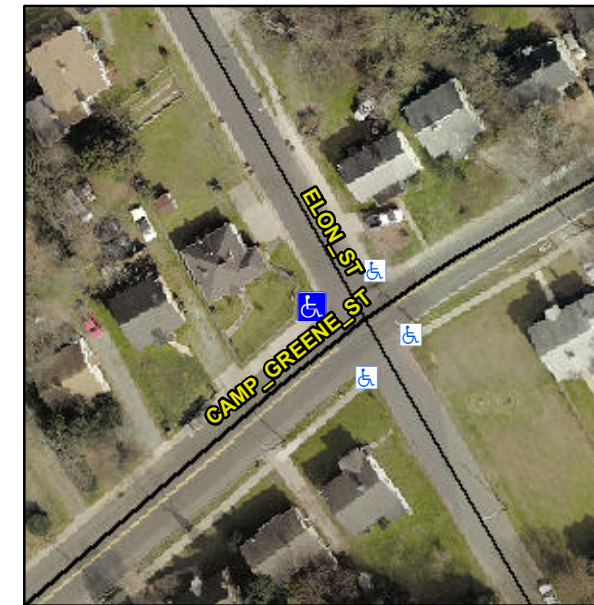
**Not Found, R304.5.1, R304.5.3**

| Compliance | Description | Data | Compliance | Description | Data |
|---|---|---|---|---|---|
| No | Ramp Width (in) | 47.0 | No | Ramp XSlope (%) | 2.4 |

**Remove & Replace Entire Ramp.**

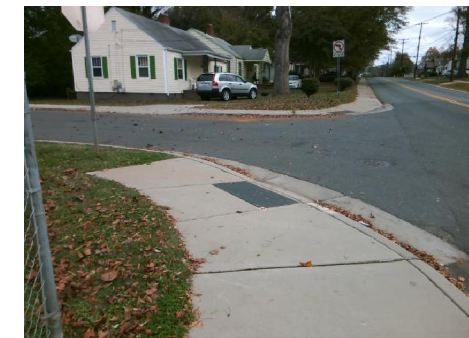
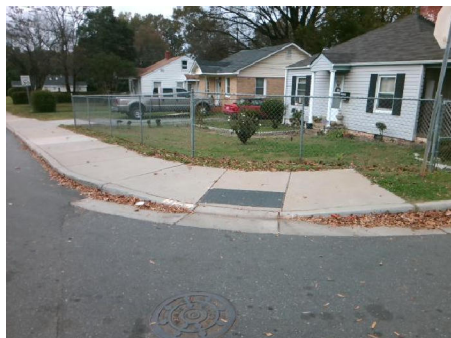
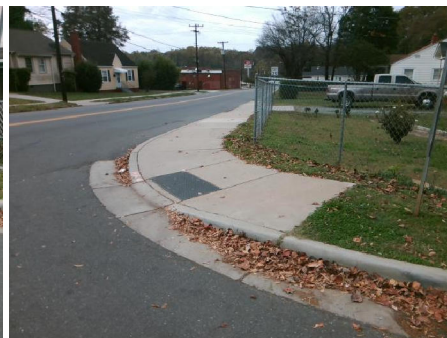
| Compliance | Description | Data | Compliance | Description | Data |
|---|---|---|---|---|---|
| N/A | Ramp Length (in) | 72.0 | Yes | Ramp Slope (%) | 7.0 |
