Access Compliance Report

Public Rights-of-Way

(Curb Ramps)

Intersection ID: 29120	Main Street: BEARD_RD	Cross Street: APPLEDALE_DR	Location: S
ADA ID: 16928D0E2B5F	Ramp Type: PerpDiag	Initial Pass/Fail: Fail	Overall Compliance: No
Severity Score: 13.75			
Codes/Mitigation Info/Possible Solution		Field Measurements/Component Compliance

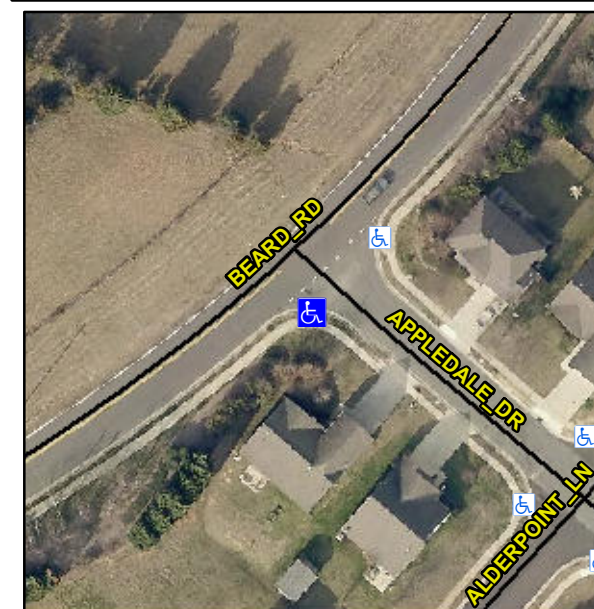
R304.2.2, R304.5.3

Compliance	Description	Data	Compliance	Description	Data
N/A	Ramp Length (in)	41.0	No	Ramp Slope (%)	9.6
Yes	Ramp Width (in)	48.0	No	Ramp XSlope (%)	4.0
N/A	Flare Type LT	N/A	N/A	Flare Type RT	N/A
N/A	Flare Slope LT (%)	N/A	N/A	Flare Slope RT (%)	N/A
N/A	Flare Traversable LT?	N/A	N/A	Flare Traversable RT?	N/A
N/A	Landing Length (in)	N/A	N/A	DWS Provided?	N/A
N/A	Landing Width (in)	N/A	N/A	DWS Contrast?	N/A
N/A	Landing Slope (%)	N/A	N/A	DWS Length (in)	N/A
N/A	Landing X Slope (%)	N/A	N/A	DWS Full Width?	N/A
N/A	Landing Curb? (Y/N)	N/A	N/A	DWS Offset (in)	N/A
N/A	Shared Landing?	N/A			
N/A	Gutter Ponding?	N/A	N/A	Gutter Slope (%)	N/A
N/A	Gutter Lip Ht (in)	N/A	N/A	Gutter X Slope (%)	N/A
N/A	Painted X Walk1?	No	N/A	Painted X Walk2?	No
	X Walk 1 Direction	To NE		X Walk 2 Direction	To NW
N/A	X Walk 1 Width (in)	N/A	N/A	X Walk 2 Width (in)	N/A
	X Walk 1 Slope (%)	2.1		X Walk 2 Slope (%)	2.6
	X Walk 1 X Slope (%)	7.2		X Walk 2 X Slope (%)	3.1

N/A	Ramp inside XWalk1?	N/A	N/A	Ramp inside XWalk2?	N/A
	Road Slope (%)	2.0	N/A	Clear Space?	N/A
	Road X Slope (%)	3.2	N/A	Clear Space to XWalk (in)	N/A
N/A	Any Obstructions?	N/A	N/A	Storm Grate/Utility Hazard?	N/A
	Obstruction Type			Storm Grate/Utility Type	
		N/A			N/A
			Yes	Surface Condition? (G/P)	Good

Remove & Replace Curb Ramp With Two New Directional Ramps or Equivalent.
