Access Compliance Report

Public Rights-of-Way

(Curb Ramps)

Intersection ID: 27531	Main Street: BALLANTYNE COMMONS PY	Cross Street: PLANTATION PARK BV	Location: NW
ADA ID: 1693277ADF5A	Ramp Type: Perp	Initial Pass/Fail: Fail	Overall Compliance: No
Codes/Mitigation Info/Possible Solution		Field Measurements/Component Compliance	
Severity Score: 10

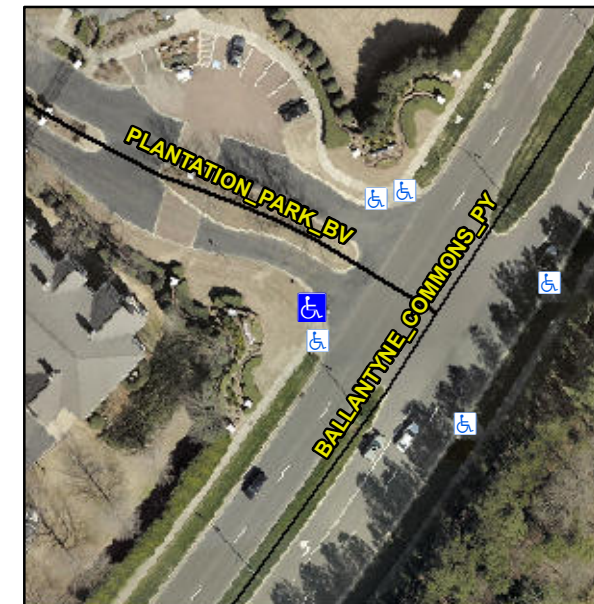
Not Found, R304.5.1, R304.5.3

Compliance	Description	Data	Compliance	Description	Data
N/A	Ramp Length (in)	107.0	Yes	Ramp Slope (%)	6.7
No	Ramp Width (in)	42.0	No	Ramp XSlope (%)	2.7
N/A	Flare Type LT	N/A	N/A	Flare Type RT	N/A
N/A	Flare Slope LT (%)	N/A	N/A	Flare Slope RT (%)	N/A
N/A	Flare Traversable LT?	N/A	N/A	Flare Traversable RT?	N/A
N/A	Landing Length (in)	N/A	N/A	DWS Provided?	N/A
N/A	Landing Width (in)	N/A	N/A	DWS Contrast?	N/A
N/A	Landing Slope (%)	N/A	N/A	DWS Length (in)	N/A
N/A	Landing X Slope (%)	N/A	N/A	DWS Full Width?	N/A
N/A	Landing Curb? (Y/N)	N/A	N/A	DWS Offset (in)	N/A
N/A	Shared Landing?	N/A			
N/A	Gutter Ponding?	N/A	N/A	Gutter Slope (%)	N/A
N/A	Gutter Lip Ht (in)	N/A	N/A	Gutter X Slope (%)	N/A
N/A	Painted X Walk1?	No	N/A	Painted X Walk2?	N/A
	X Walk 1 Direction	To NE		X Walk 2 Direction	N/A
N/A	X Walk 1 Width (in)	N/A	N/A	X Walk 2 Width (in)	N/A
	X Walk 1 Slope (%)	6.7		X Walk 2 Slope (%)	N/A
	X Walk 1 X Slope (%)	0.4		X Walk 2 X Slope (%)	N/A

N/A	Ramp inside XWalk1?	N/A	N/A	Ramp inside XWalk2?	N/A
	Road Slope (%)	N/A	N/A	Clear Space?	N/A
	Road X Slope (%)	N/A	N/A	Clear Space to XWalk (in)	N/A
N/A	Any Obstructions?	N/A	N/A	Storm Grate/Utility Hazard?	N/A
	Obstruction Type			Storm Grate/Utility Type	
		N/A			N/A
			Yes	Surface Condition? (G/P)	Good

Remove & Replace Entire Ramp.

Total Cost: \$ 1850.00
