Access Compliance Report Public Rights-of-Way (Curb Ramps)

Intersection ID: 9617 Main Street: CATALINA_AV Cross Street: W_28TH_ST Location: S

ADA ID: 16AE50017646 Ramp Type: Para Initial Pass/Fail: Fail Overall Compliance: No Severity Score: 58.75

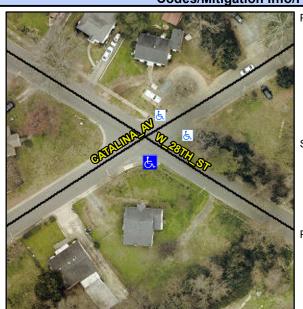
Field Measurements/Component Compilance					
Compliance Description		Data	Compliance Description		Data
N/A	Ramp Length LT (in)	46.0	N/A	Ramp Length RT (in)	48.0
No	Ramp Width LT (in)	46.0	Yes	Ramp Width RT (in)	52.0
No	Ramp Slope LT (%)	8.5	No	Ramp Slope RT (%)	12.1
No	Ramp XSlope LT (%)	8.4	No	Ramp XSlope RT (%)	7.4
N/A	Landing Length (in)	N/A	N/A	DWS Provided?	N/A
N/A	Landing Width (in)	N/A	N/A	DWS Contrast?	N/A
N/A	Landing Slope (%)	N/A	N/A	DWS Length (in)	N/A
N/A	Landing X Slope (%)	N/A	N/A	DWS Full Width?	N/A
N/A	Landing Curb? (Y/N)	N/A	N/A	DWS Offset (in)	N/A
N/A	Shared Landing?	N/A			
N/A	Gutter Ponding?	N/A	N/A	Gutter Slope (%)	N/A
N/A	Gutter Lip Ht (in)	0.5	N/A	Gutter X Slope (%)	N/A
N/A	Painted X Walk1?	No	N/A	Painted X Walk2?	N/A
	X Walk 1 Direction	To NE		X Walk 2 Direction	N/A
N/A	X Walk 1 Width (in)	N/A	N/A	X Walk 2 Width (in)	N/A
	X Walk 1 Slope (%)	4.7		X Walk 2 Slope (%)	N/A
	X Walk 1 X Slope (%)	4.3		X Walk 2 X Slope (%)	N/A

N/A	Ramp inside XWalk1?	N/A	N/A	Ramp inside XWalk2?	N/A
	Road Slope (%)	N/A	N/A	Clear Space?	N/A
	Road X Slope (%)	N/A	N/A	Clear Space to XWalk (in)	N/A
N/A	Any Obstructions?	N/A	N/A	Storm Grate/Utility Hazard?	N/A
	Obstruction Type			Storm Grate/Utility Type	
		N/A			N/A
			Yes	Surface Condition? (G/P)	Good
			N/A	Curb Slope (%)	N/A

Possible Solutions:

Remove & Replace Entire Ramp.

R304.5.1, R304.3.2, R304.5.3
