# Access Compliance Report

## Public Rights-of-Way

### (Curb Ramps)

Intersection ID: 31738	Main Street: LEAF_PLUM_DR	Cross Street: SAWLEAF_CT	Location: NW
ADA ID: 16C61469DF86	Ramp Type: PerpDiag	Initial Pass/Fail: Fail	Overall Compliance: No
		Severity Score: 12.5

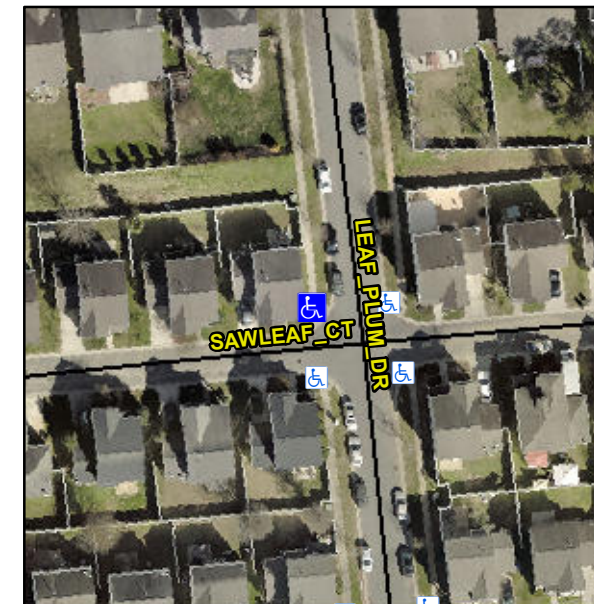
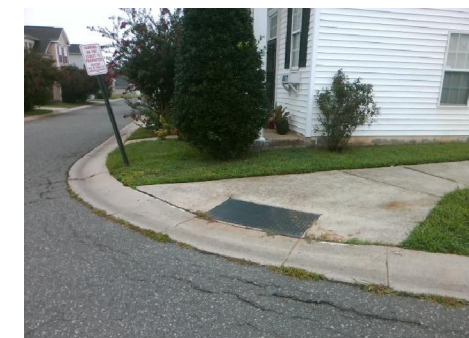
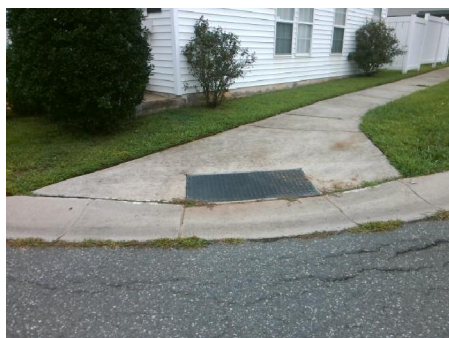
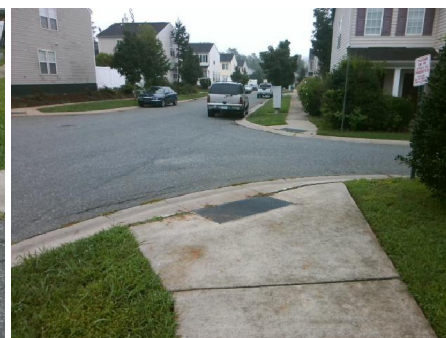
Compliance	Description	Data	Compliance	Description	Data
N/A	Ramp Length (in)	67.0	No	Ramp Slope (%)	9.3
Yes	Ramp Width (in)	48.0	Yes	Ramp XSlope (%)	1.9
N/A	Flare Type LT	N/A	N/A	Flare Type RT	N/A
N/A	Flare Slope LT (%)	N/A	N/A	Flare Slope RT (%)	N/A
N/A	Flare Traversable LT?	N/A	N/A	Flare Traversable RT?	N/A
N/A	Landing Length (in)	N/A	N/A	DWS Provided?	N/A
N/A	Landing Width (in)	N/A	N/A	DWS Contrast?	N/A
N/A	Landing Slope (%)	N/A	N/A	DWS Length (in)	N/A
N/A	Landing X Slope (%)	N/A	N/A	DWS Full Width?	N/A
N/A	Landing Curb? (Y/N)	N/A	N/A	DWS Offset (in)	N/A
N/A	Shared Landing?	N/A			
N/A	Gutter Ponding?	N/A	N/A	Gutter Slope (%)	N/A
N/A	Gutter Lip Ht (in)	0.5	N/A	Gutter X Slope (%)	N/A
N/A	Painted X Walk1?	No	N/A	Painted X Walk2?	No
	X Walk 1 Direction	To S		X Walk 2 Direction	To E
N/A	X Walk 1 Width (in)	N/A	N/A	X Walk 2 Width (in)	N/A
	X Walk 1 Slope (%)	3.5		X Walk 2 Slope (%)	2.5
	X Walk 1 X Slope (%)	1.3		X Walk 2 X Slope (%)	2.8

N/A	Ramp inside XWalk1?	N/A	N/A	Ramp inside XWalk2?	N/A
	Road Slope (%)	3.0	N/A	Clear Space?	N/A
	Road X Slope (%)	3.4	N/A	Clear Space to XWalk (in)	N/A
N/A	Any Obstructions?	N/A	N/A	Storm Grate/Utility Hazard?	N/A
	Obstruction Type			Storm Grate/Utility Type	
		N/A			N/A
			Yes	Surface Condition? (G/P)	Good

**Remove & Replace Curb Ramp With Two New Directional Ramps or Equivalent.**

**Not Found, R304.2.2**
