# Access Compliance Report

## Public Rights-of-Way (Curb Ramps)

Intersection ID: 2587	Main Street: KILMARTIN_LN	Cross Street: MCCHESENEY_DR	Location: S
ADA ID: 16C633AB00D3	Ramp Type: PerpDiag	Initial Pass/Fail: Pass	Overall Compliance: No Severity Score: 17.75

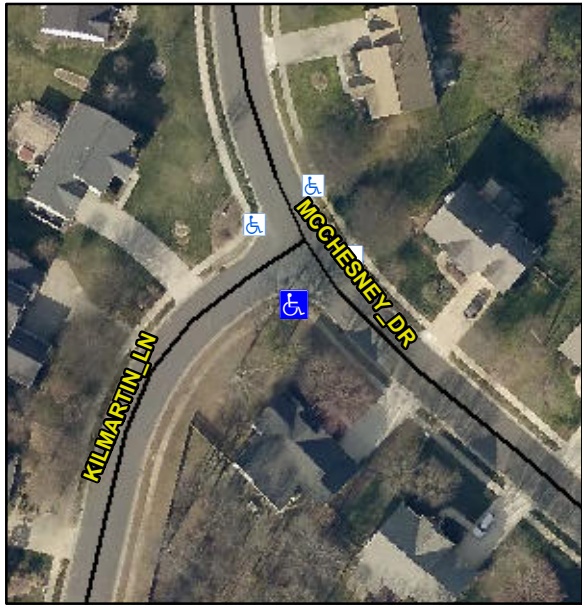
Possible Solutions:		Compliance	Description	Data	Compliance	Description	Data
	Remove & Replace Curb Ramp With Two New Directional Ramps or Equivalent. Remove & Replace Gutter.		N/A	Ramp Length (in)	46.0	Yes	Ramp Slope (%)	6.5
			Yes	Ramp Width (in)	48.0	No	Ramp XSlope (%)	3.5
			N/A	Flare Type LT	Sloped	N/A	Flare Type RT	N/A
			N/A	Flare Slope LT (%)	1.4	Yes	Flare Slope RT (%)	3.8
			N/A	Flare Traversable LT?	Yes	N/A	Flare Traversable RT?	Yes
			Yes	Landing Length (in)	48.0	No	DWS Provided?	No
			Yes	Landing Width (in)	55.0	N/A	DWS Contrast?	No
			Yes	Landing Slope (%)	0.4	N/A	DWS Length (in)	N/A
			No	Landing X Slope (%)	4.0	N/A	DWS Full Width?	No
Surveyor Notes:		N/A	N/A	Landing Curb? (Y/N)	No	N/A	DWS Offset (in)	N/A
PROW/ADA:		Not Found, R304.5.3, R305, R302.7.2	N/A	Shared Landing?	No			
			Yes	Gutter Ponding?	No	Yes	Gutter Slope (%)	0.1

No	Gutter Lip Ht (in)	0.5	No	Gutter X Slope (%)	2.1
			N/A	Painted X Walk1?	No	N/A	Painted X Walk2?	No
				X Walk 1 Direction	To E		X Walk 2 Direction	To N
			N/A	X Walk 1 Width (in)	N/A	N/A	X Walk 2 Width (in)	N/A
				X Walk 1 Slope (%)	1.8		X Walk 2 Slope (%)	2.6
				X Walk 1 X Slope (%)	1.5		X Walk 2 X Slope (%)	1.2
			N/A	Ramp inside XWalk1?	N/A	N/A	Ramp inside XWalk2?	N/A
				Road Slope (%)	2.0	N/A	Clear Space?	Yes
				Road X Slope (%)	3.0	N/A	Clear Space to XWalk (in)	N/A
			Yes	Any Obstructions?	No	Yes	Storm Grate/Utility Hazard?	No
				Obstruction Type			Storm Grate/Utility Type	
					N/A			N/A
						Yes	Surface Condition? (G/P)	Good
Total Cost:		\$ 3950.00
