Access Compliance Report

Public Rights-of-Way

(Curb Ramps)

Intersection ID: 15561	Main Street: CUTLER_PL	Cross Street: PIERSON_DR	Location: S
ADA ID: 16D58BE71DB5	Ramp Type: Perp	Initial Pass/Fail: Fail	Overall Compliance: No
Severity Score: 48.75			
Codes/Mitigation Info/Possible Solution		Field Measurements/Component Compliance

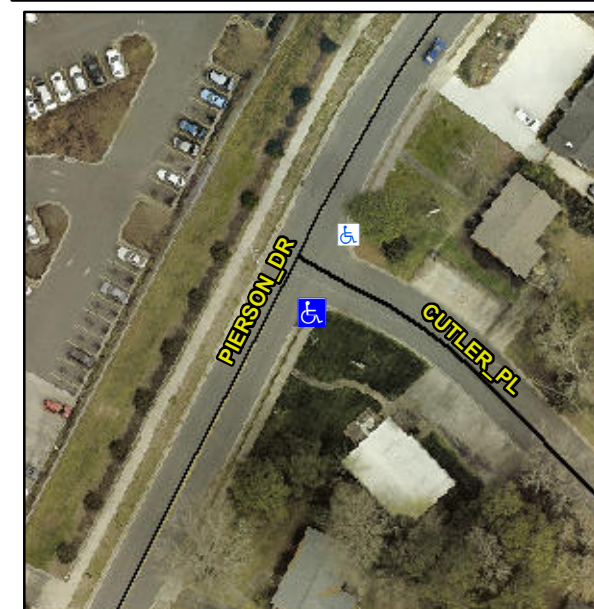
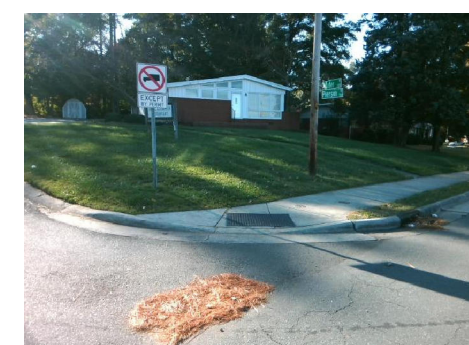
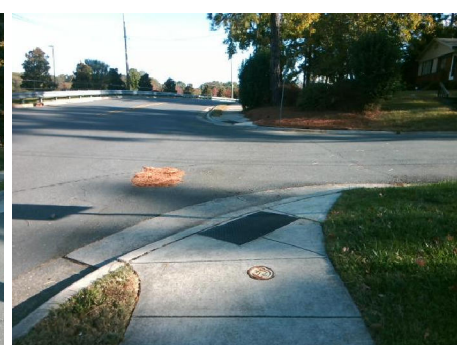
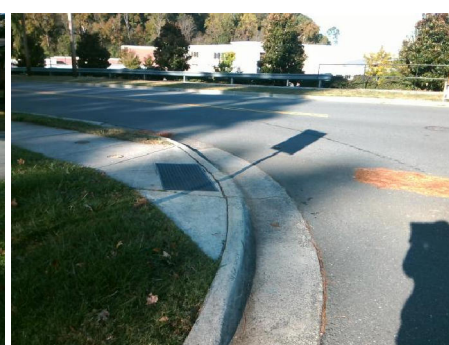
Not Found, R304.5.1, R304.2.2, R304.5.3

Compliance	Description	Data	Compliance	Description	Data
N/A	Ramp Length (in)	40.5	No	Ramp Slope (%)	8.7
No	Ramp Width (in)	31.0	No	Ramp XSlope (%)	2.9
N/A	Flare Type LT	N/A	N/A	Flare Type RT	N/A
N/A	Flare Slope LT (%)	N/A	N/A	Flare Slope RT (%)	N/A
N/A	Flare Traversable LT?	N/A	N/A	Flare Traversable RT?	N/A
N/A	Landing Length (in)	N/A	N/A	DWS Provided?	N/A
N/A	Landing Width (in)	N/A	N/A	DWS Contrast?	N/A
N/A	Landing Slope (%)	N/A	N/A	DWS Length (in)	N/A
N/A	Landing X Slope (%)	N/A	N/A	DWS Full Width?	N/A
N/A	Landing Curb? (Y/N)	N/A	N/A	DWS Offset (in)	N/A
N/A	Shared Landing?	N/A			
N/A	Gutter Ponding?	N/A	N/A	Gutter Slope (%)	N/A
N/A	Gutter Lip Ht (in)	N/A	N/A	Gutter X Slope (%)	N/A
N/A	Painted X Walk1?	No	N/A	Painted X Walk2?	N/A
	X Walk 1 Direction	To NE		X Walk 2 Direction	N/A
N/A	X Walk 1 Width (in)	N/A	N/A	X Walk 2 Width (in)	N/A
	X Walk 1 Slope (%)	1.9		X Walk 2 Slope (%)	N/A
	X Walk 1 X Slope (%)	0.5		X Walk 2 X Slope (%)	N/A

N/A	Ramp inside XWalk1?	N/A	N/A	Ramp inside XWalk2?	N/A
	Road Slope (%)	N/A	N/A	Clear Space?	N/A
	Road X Slope (%)	N/A	N/A	Clear Space to XWalk (in)	N/A
N/A	Any Obstructions?	N/A	N/A	Storm Grate/Utility Hazard?	N/A
	Obstruction Type			Storm Grate/Utility Type	
		N/A			N/A
			Yes	Surface Condition? (G/P)	Good

Possible Solutions:

Remove & Replace Entire Ramp.
