# Access Compliance Report

## Public Rights-of-Way

### (Curb Ramps)

Intersection ID: 10025310	Main Street: E_5TH_ST	Cross Street: N/A	Location: S
ADA ID: 16E0CAABD75E	Ramp Type: Perp	Initial Pass/Fail: Pass	Overall Compliance: No
Severity Score: 0			
Codes/Mitigation Info/Possible Solution		Field Measurements/Component Compliance

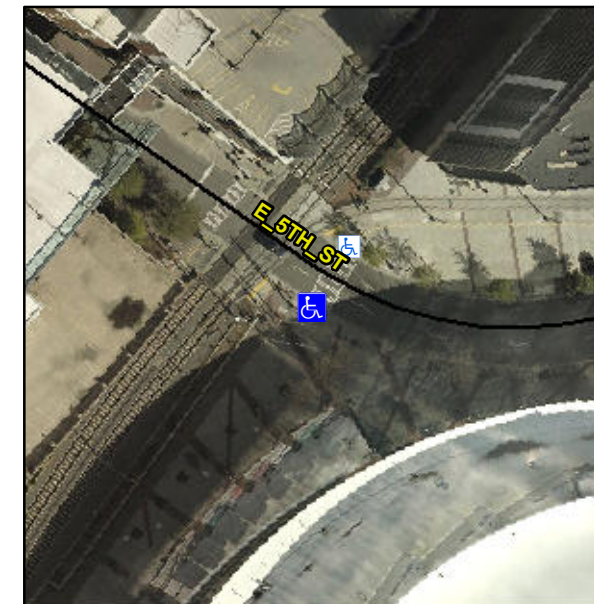
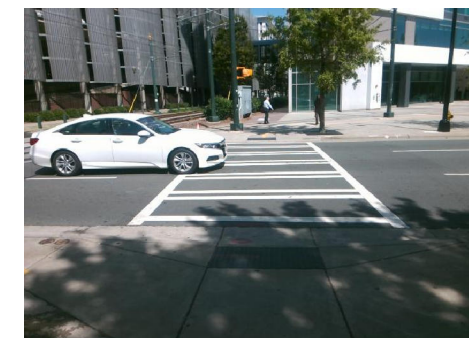
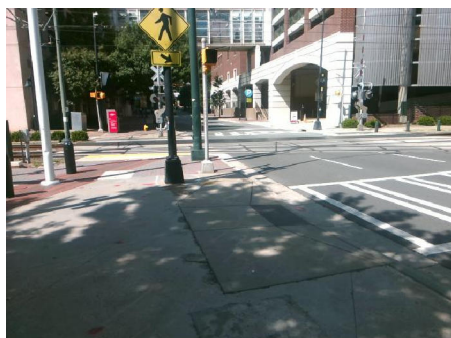
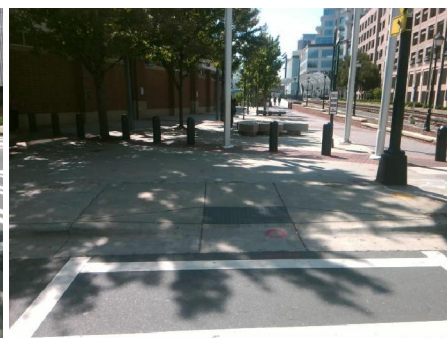
**Not Found, R304.5.3**

Compliance	Description	Data	Compliance	Description	Data
N/A	Ramp Length (in)	73.0	Yes	Ramp Slope (%)	7.5
Yes	Ramp Width (in)	48.0	Yes	Ramp XSlope (%)	1.2
N/A	Flare Type LT	Sloped	N/A	Flare Type RT	N/A
N/A	Flare Slope LT (%)	3.0	Yes	Flare Slope RT (%)	6.5
N/A	Flare Traversable LT?	Yes	N/A	Flare Traversable RT?	Yes
Yes	Landing Length (in)	48.0	Yes	DWS Provided?	Yes
Yes	Landing Width (in)	48.0	Yes	DWS Contrast?	Yes
Yes	Landing Slope (%)	1.3	Yes	DWS Length (in)	24.0
Yes	Landing X Slope (%)	0.9	Yes	DWS Full Width?	Yes
N/A	Landing Curb? (Y/N)	No	Yes	DWS Offset (in)	0.0
N/A	Shared Landing?	No			
Yes	Gutter Ponding?	No	Yes	Gutter Slope (%)	0.1
Yes	Gutter Lip Ht (in)	0.0	No	Gutter X Slope (%)	3.1
N/A	Painted X Walk1?	Yes	N/A	Painted X Walk2?	N/A
	X Walk 1 Direction	To NE		X Walk 2 Direction	N/A
N/A	X Walk 1 Width (in)	142.0	N/A	X Walk 2 Width (in)	N/A
	X Walk 1 Slope (%)	1.7		X Walk 2 Slope (%)	N/A
	X Walk 1 X Slope (%)	0.7		X Walk 2 X Slope (%)	N/A

Yes	Ramp inside XWalk1?	Yes	N/A	Ramp inside XWalk2?	N/A
	Road Slope (%)	N/A	N/A	Clear Space?	Yes
	Road X Slope (%)	N/A	N/A	Clear Space to XWalk (in)	N/A
Yes	Any Obstructions?	No	Yes	Storm Grate/Utility Hazard?	No
	Obstruction Type			Storm Grate/Utility Type	
		N/A			N/A
			Yes	Surface Condition? (G/P)	Good

**Remove & Replace Entire Ramp.  
Remove & Replace Gutter.**
