Access Compliance Report

Public Rights-of-Way

(Curb Ramps)

Intersection ID: 48600	Main Street: GRANDIFLORA_DR	Cross Street: N/A	Location:	N
ADA ID: 16E5DFA01E3B	Ramp Type: Perp	Initial Pass/Fail: Fail	Overall Compliance: No	Severity Score: 25
Codes/Mitigation Info/Possible Solution		Field Measurements/Component Compliance

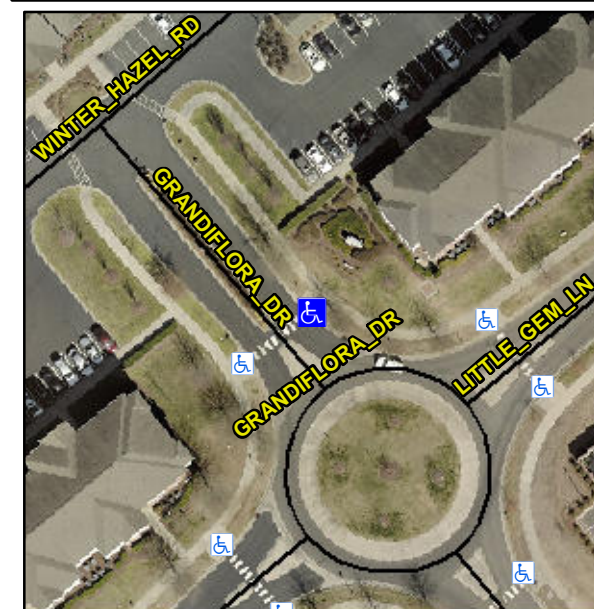
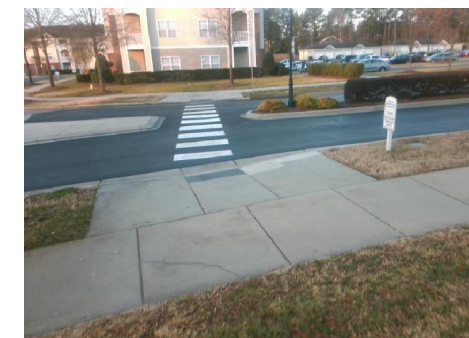
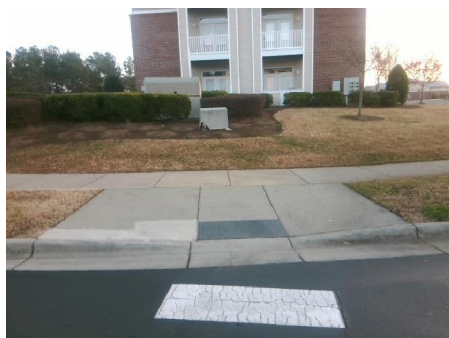
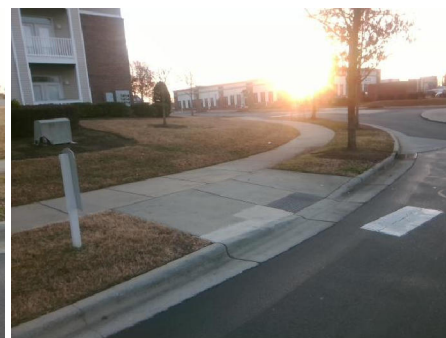
Not Found, R304.2.2, R304.5.3

Compliance	Description	Data	Compliance	Description	Data
N/A	Ramp Length (in)	96.0	No	Ramp Slope (%)	9.7
Yes	Ramp Width (in)	48.0	No	Ramp XSlope (%)	5.3
N/A	Flare Type LT	N/A	N/A	Flare Type RT	N/A
N/A	Flare Slope LT (%)	N/A	N/A	Flare Slope RT (%)	N/A
N/A	Flare Traversable LT?	N/A	N/A	Flare Traversable RT?	N/A
N/A	Landing Length (in)	N/A	N/A	DWS Provided?	N/A
N/A	Landing Width (in)	N/A	N/A	DWS Contrast?	N/A
N/A	Landing Slope (%)	N/A	N/A	DWS Length (in)	N/A
N/A	Landing X Slope (%)	N/A	N/A	DWS Full Width?	N/A
N/A	Landing Curb? (Y/N)	N/A	N/A	DWS Offset (in)	N/A
N/A	Shared Landing?	N/A			
N/A	Gutter Ponding?	N/A	N/A	Gutter Slope (%)	N/A
N/A	Gutter Lip Ht (in)	N/A	N/A	Gutter X Slope (%)	N/A
N/A	Painted X Walk1?	Yes	N/A	Painted X Walk2?	N/A
	X Walk 1 Direction	To SW		X Walk 2 Direction	N/A
N/A	X Walk 1 Width (in)	60.0	N/A	X Walk 2 Width (in)	N/A
	X Walk 1 Slope (%)	0.7		X Walk 2 Slope (%)	N/A
	X Walk 1 X Slope (%)	2.9		X Walk 2 X Slope (%)	N/A

N/A	Ramp inside XWalk1?	Yes	N/A	Ramp inside XWalk2?	N/A
	Road Slope (%)	N/A	N/A	Clear Space?	N/A
	Road X Slope (%)	N/A	N/A	Clear Space to XWalk (in)	N/A
N/A	Any Obstructions?	N/A	N/A	Storm Grate/Utility Hazard?	N/A
	Obstruction Type			Storm Grate/Utility Type	
		N/A			N/A
			Yes	Surface Condition? (G/P)	Good

Remove & Replace Entire Ramp.

Total Cost: \$ 1850.00
