Access Compliance Report

Public Rights-of-Way

(Curb Ramps)

Intersection ID: 20923	Main Street: LANSLOWNE_RD	Cross Street: OWENBY_CT	Location: S
ADA ID: 16E9AC920BF0	Ramp Type: PerpDiag	Initial Pass/Fail: Fail	Overall Compliance: No
		Severity Score: 10

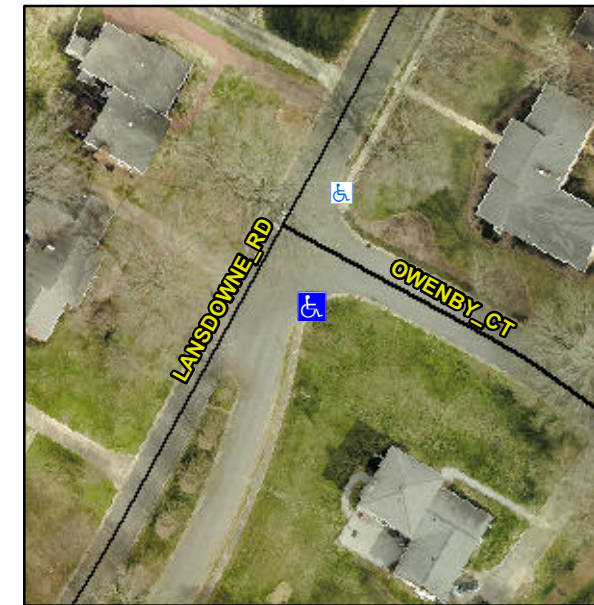
Not Found, R304.5.1, R304.5.3

Compliance	Description	Data	Compliance	Description	Data
N/A	Ramp Length (in)	46.5	Yes	Ramp Slope (%)	5.8
No	Ramp Width (in)	40.0	No	Ramp XSlope (%)	3.1
N/A	Flare Type LT	N/A	N/A	Flare Type RT	N/A
N/A	Flare Slope LT (%)	N/A	N/A	Flare Slope RT (%)	N/A
N/A	Flare Traversable LT?	N/A	N/A	Flare Traversable RT?	N/A
N/A	Landing Length (in)	N/A	N/A	DWS Provided?	N/A
N/A	Landing Width (in)	N/A	N/A	DWS Contrast?	N/A
N/A	Landing Slope (%)	N/A	N/A	DWS Length (in)	N/A
N/A	Landing X Slope (%)	N/A	N/A	DWS Full Width?	N/A
N/A	Landing Curb? (Y/N)	N/A	N/A	DWS Offset (in)	N/A
N/A	Shared Landing?	N/A			
N/A	Gutter Ponding?	N/A	N/A	Gutter Slope (%)	N/A
N/A	Gutter Lip Ht (in)	N/A	N/A	Gutter X Slope (%)	N/A
N/A	Painted X Walk1?	No	N/A	Painted X Walk2?	No
	X Walk 1 Direction	To NE		X Walk 2 Direction	To NW
N/A	X Walk 1 Width (in)	N/A	N/A	X Walk 2 Width (in)	N/A
	X Walk 1 Slope (%)	4.4		X Walk 2 Slope (%)	4.9
	X Walk 1 X Slope (%)	1.6		X Walk 2 X Slope (%)	2.3

N/A	Ramp inside XWalk1?	N/A	N/A	Ramp inside XWalk2?	N/A
	Road Slope (%)	2.0	N/A	Clear Space?	N/A
	Road X Slope (%)	4.0	N/A	Clear Space to XWalk (in)	N/A
N/A	Any Obstructions?	N/A	N/A	Storm Grate/Utility Hazard?	N/A
	Obstruction Type			Storm Grate/Utility Type	
		N/A			N/A
		Yes		Surface Condition? (G/P)	Good

Remove & Replace Curb Ramp With Two New Directional Ramps or Equivalent.
