Access Compliance Report

Public Rights-of-Way

(Curb Ramps)

Intersection ID: 30144	Main Street: CAGNEY_ST	Cross Street: RUMPLE_RD	Location:	N
ADA ID: 16EC160A177B	Ramp Type: Perp	Initial Pass/Fail: Fail	Overall Compliance: No	Severity Score: 10

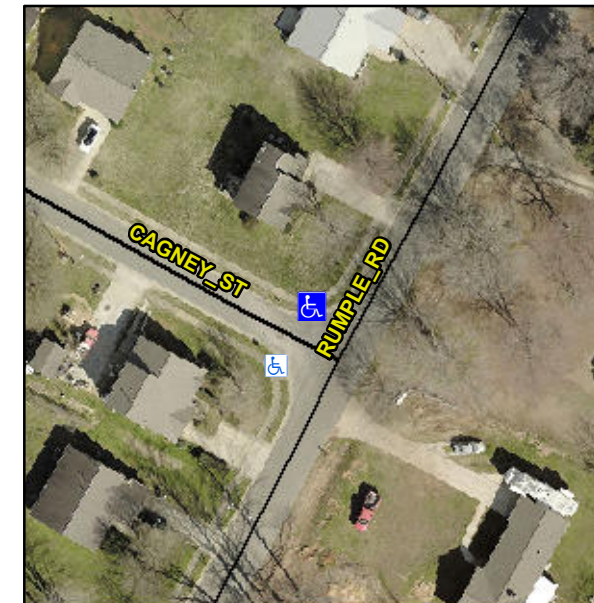
Not Found, R304.5.1, R304.5.3

Compliance	Description	Data	Compliance	Description	Data
N/A	Ramp Length (in)	49.0	Yes	Ramp Slope (%)	5.2
No	Ramp Width (in)	44.0	No	Ramp XSlope (%)	2.6
N/A	Flare Type LT	N/A	N/A	Flare Type RT	N/A
N/A	Flare Slope LT (%)	N/A	N/A	Flare Slope RT (%)	N/A
N/A	Flare Traversable LT?	N/A	N/A	Flare Traversable RT?	N/A
N/A	Landing Length (in)	N/A	N/A	DWS Provided?	N/A
N/A	Landing Width (in)	N/A	N/A	DWS Contrast?	N/A
N/A	Landing Slope (%)	N/A	N/A	DWS Length (in)	N/A
N/A	Landing X Slope (%)	N/A	N/A	DWS Full Width?	N/A
N/A	Landing Curb? (Y/N)	N/A	N/A	DWS Offset (in)	N/A
N/A	Shared Landing?	N/A			
N/A	Gutter Ponding?	N/A	N/A	Gutter Slope (%)	N/A
N/A	Gutter Lip Ht (in)	N/A	N/A	Gutter X Slope (%)	N/A
N/A	Painted X Walk1?	No	N/A	Painted X Walk2?	N/A
	X Walk 1 Direction	To SW		X Walk 2 Direction	N/A
N/A	X Walk 1 Width (in)	N/A	N/A	X Walk 2 Width (in)	N/A
	X Walk 1 Slope (%)	0.4		X Walk 2 Slope (%)	N/A
	X Walk 1 X Slope (%)	0.6		X Walk 2 X Slope (%)	N/A

N/A	Ramp inside XWalk1?	N/A	N/A	Ramp inside XWalk2?	N/A
	Road Slope (%)	N/A	N/A	Clear Space?	N/A
	Road X Slope (%)	N/A	N/A	Clear Space to XWalk (in)	N/A
N/A	Any Obstructions?	N/A	N/A	Storm Grate/Utility Hazard?	N/A
	Obstruction Type			Storm Grate/Utility Type	
		N/A			N/A
			Yes	Surface Condition? (G/P)	Good

Remove & Replace Entire Ramp.

Total Cost: \$ 1850.00
