Access Compliance Report

Public Rights-of-Way

(Curb Ramps)

| Intersection ID: 29162 | Main Street: FIRESTREAK_DR | Cross Street: ADVOCATOR_LN | Location: NW |

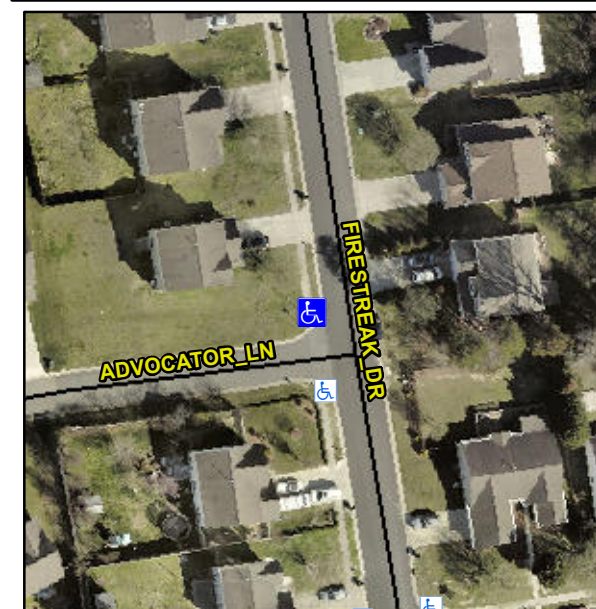
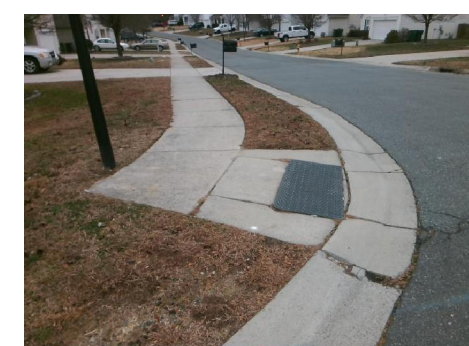
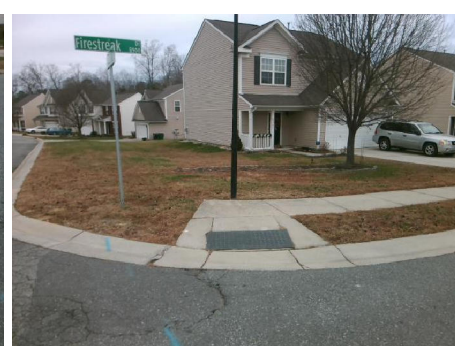
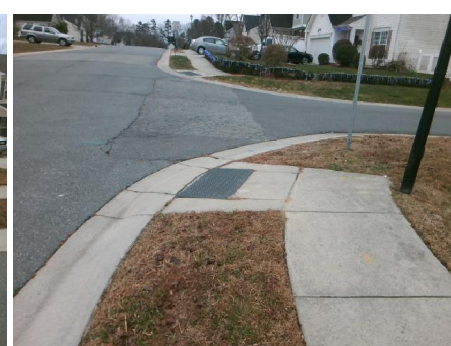
| ADA ID: 16F3C0217447 | Ramp Type: Perp | Initial Pass/Fail: Fail | Overall Compliance: No |
| Severity Score: 8.75 | | | |

R304.5.1

| Compliance | Description | Data | Compliance | Description | Data |
|---|---|---|---|---|---|
| No | Ramp Width (in) | 40.0 | Yes | Ramp XSlope (%) | 0.9 |

Remove & Replace Entire Ramp.

\$ 1850.00
