Access Compliance Report

Public Rights-of-Way

(Curb Ramps)

Intersection ID: 46182	Main Street: SEVEN_OAKS_DR	Cross Street: GLOXINIA_RD	Location: W
ADA ID: 16F430EB6E24	Ramp Type: Perp	Initial Pass/Fail: Fail	Overall Compliance: No
Severity Score: 12.5			
Codes/Mitigation Info/Possible Solution		Field Measurements/Component Compliance

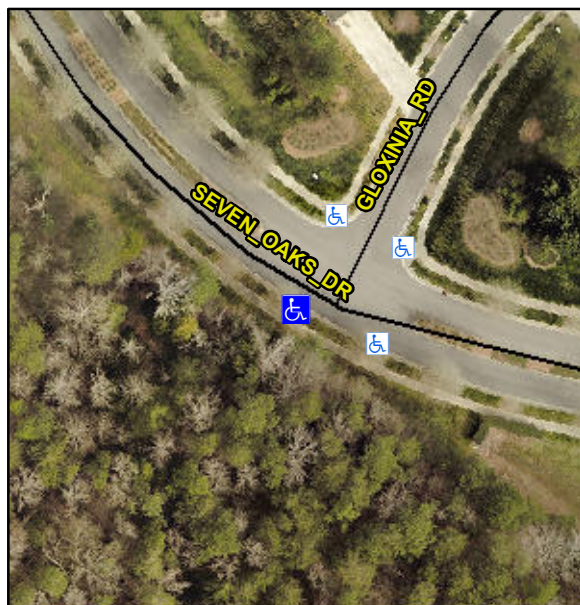
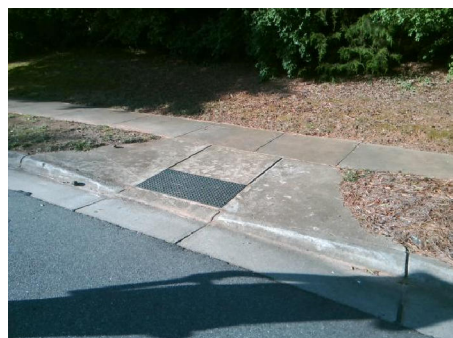
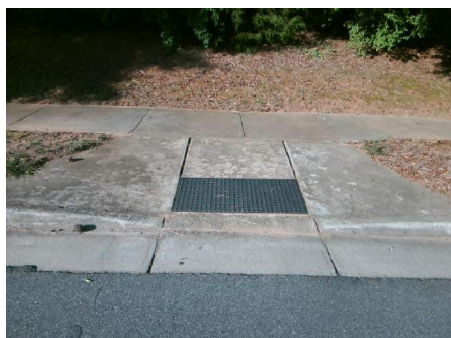
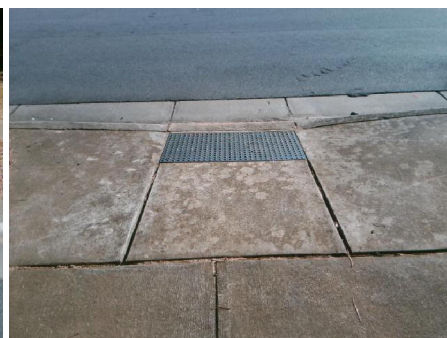
Not Found, R304.2.2

Compliance	Description	Data	Compliance	Description	Data
N/A	Ramp Length (in)	71.5	No	Ramp Slope (%)	9.1
Yes	Ramp Width (in)	48.0	Yes	Ramp XSlope (%)	0.5
N/A	Flare Type LT	N/A	N/A	Flare Type RT	N/A
N/A	Flare Slope LT (%)	N/A	N/A	Flare Slope RT (%)	N/A
N/A	Flare Traversable LT?	N/A	N/A	Flare Traversable RT?	N/A
N/A	Landing Length (in)	N/A	N/A	DWS Provided?	N/A
N/A	Landing Width (in)	N/A	N/A	DWS Contrast?	N/A
N/A	Landing Slope (%)	N/A	N/A	DWS Length (in)	N/A
N/A	Landing X Slope (%)	N/A	N/A	DWS Full Width?	N/A
N/A	Landing Curb? (Y/N)	N/A	N/A	DWS Offset (in)	N/A
N/A	Shared Landing?	N/A			
N/A	Gutter Ponding?	N/A	N/A	Gutter Slope (%)	N/A
N/A	Gutter Lip Ht (in)	N/A	N/A	Gutter X Slope (%)	N/A
N/A	Painted X Walk1?	No	N/A	Painted X Walk2?	N/A
	X Walk 1 Direction	To NE		X Walk 2 Direction	N/A
N/A	X Walk 1 Width (in)	N/A	N/A	X Walk 2 Width (in)	N/A
	X Walk 1 Slope (%)	3.2		X Walk 2 Slope (%)	N/A
	X Walk 1 X Slope (%)	1.1		X Walk 2 X Slope (%)	N/A

N/A	Ramp inside XWalk1?	N/A	N/A	Ramp inside XWalk2?	N/A
	Road Slope (%)	N/A	N/A	Clear Space?	N/A
	Road X Slope (%)	N/A	N/A	Clear Space to XWalk (in)	N/A
N/A	Any Obstructions?	N/A	N/A	Storm Grate/Utility Hazard?	N/A
	Obstruction Type			Storm Grate/Utility Type	
		N/A			N/A
			Yes	Surface Condition? (G/P)	Good

Remove & Replace Entire Ramp.
