Access Compliance Report

Public Rights-of-Way

(Curb Ramps)

Intersection ID: 8700	Main Street: L_D PARKER DR	Cross Street: HOLLAND_AV	Location:	SE
ADA ID: 16FCF0A27179	Ramp Type: PerpDiag	Initial Pass/Fail: Fail	Overall Compliance: No	Severity Score: 60
Codes/Mitigation Info/Possible Solution		Field Measurements/Component Compliance

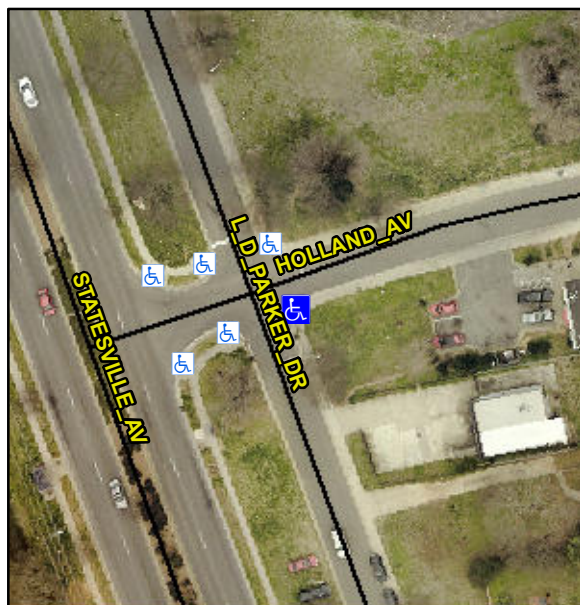
Not Found, R304.5.1, R304.5.3

Compliance	Description	Data	Compliance	Description	Data
N/A	Ramp Length (in)	59.0	Yes	Ramp Slope (%)	5.7
No	Ramp Width (in)	25.0	No	Ramp XSlope (%)	7.2
N/A	Flare Type LT	N/A	N/A	Flare Type RT	N/A
N/A	Flare Slope LT (%)	N/A	N/A	Flare Slope RT (%)	N/A
N/A	Flare Traversable LT?	N/A	N/A	Flare Traversable RT?	N/A
N/A	Landing Length (in)	N/A	N/A	DWS Provided?	N/A
N/A	Landing Width (in)	N/A	N/A	DWS Contrast?	N/A
N/A	Landing Slope (%)	N/A	N/A	DWS Length (in)	N/A
N/A	Landing X Slope (%)	N/A	N/A	DWS Full Width?	N/A
N/A	Landing Curb? (Y/N)	N/A	N/A	DWS Offset (in)	N/A
N/A	Shared Landing?	N/A			
N/A	Gutter Ponding?	N/A	N/A	Gutter Slope (%)	N/A
N/A	Gutter Lip Ht (in)	N/A	N/A	Gutter X Slope (%)	N/A
N/A	Painted X Walk1?	No	N/A	Painted X Walk2?	No
	X Walk 1 Direction	To N		X Walk 2 Direction	To W
N/A	X Walk 1 Width (in)	N/A	N/A	X Walk 2 Width (in)	N/A
	X Walk 1 Slope (%)	4.2		X Walk 2 Slope (%)	0.3
	X Walk 1 X Slope (%)	2.4		X Walk 2 X Slope (%)	5.4

N/A	Ramp inside XWalk1?	N/A	N/A	Ramp inside XWalk2?	N/A
	Road Slope (%)	4.0	N/A	Clear Space?	N/A
	Road X Slope (%)	6.7	N/A	Clear Space to XWalk (in)	N/A
N/A	Any Obstructions?	N/A	N/A	Storm Grate/Utility Hazard?	N/A
	Obstruction Type			Storm Grate/Utility Type	
		N/A			N/A
		Yes		Surface Condition? (G/P)	Good

Remove & Replace Curb Ramp With Two New Directional Ramps or Equivalent.
