## Access Compliance Report Public Rights-of-Way (Curb Ramps)

Intersection ID: 19048
 Main Street: CORY-BRET\_LN
 Cross Street: SHOPTON\_RD\_WEST
 Location:
 SW

ADA ID: 170201DB79CC
 Ramp Type: PerpDiag
 Initial Pass/Fail: Fail
 Overall Compliance: No
 Severity Score:
 25

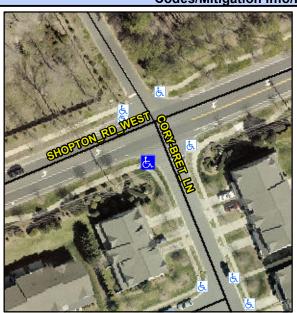
Field Measurements/Component Compliance					
Compliance Description		Data	Compliance Description		Data
N/A	Ramp Length (in)	54.0	Yes	Ramp Slope (%)	7.6
Yes	Ramp Width (in)	53.0	No	Ramp XSlope (%)	7.1
N/A	Flare Type LT	N/A	N/A	Flare Type RT	N/A
N/A	Flare Slope LT (%)	N/A	N/A	Flare Slope RT (%)	N/A
N/A	Flare Traversable LT?	N/A	N/A	Flare Traversable RT?	N/A
N/A	Landing Length (in)	N/A	N/A	DWS Provided?	N/A
N/A	Landing Width (in)	N/A	N/A	DWS Contrast?	N/A
N/A	Landing Slope (%)	N/A	N/A	DWS Length (in)	N/A
N/A	Landing X Slope (%)	N/A	N/A	DWS Full Width?	N/A
N/A	Landing Curb? (Y/N)	N/A	N/A	DWS Offset (in)	N/A
N/A	Shared Landing?	N/A			
N/A	Gutter Ponding?	N/A	N/A	Gutter Slope (%)	N/A
N/A	Gutter Lip Ht (in)	N/A	N/A	Gutter X Slope (%)	N/A
N/A	Painted X Walk1?	No	N/A	Painted X Walk2?	No
	X Walk 1 Direction	То Е		X Walk 2 Direction	To NW
N/A	X Walk 1 Width (in)	N/A	N/A	X Walk 2 Width (in)	N/A
	X Walk 1 Slope (%)	2.0		X Walk 2 Slope (%)	10.4

X Walk 1 X Slope (%)	6.3		X Walk 2 X Slope (%)	0.0
N/A	Ramp inside XWalk1?	N/A	N/A	Ramp inside XWalk2?	N/A
	Road Slope (%)	4.4	N/A	Clear Space?	N/A
	Road X Slope (%)	4.6	N/A	Clear Space to XWalk (in)	N/A
N/A	Any Obstructions?	N/A	N/A	Storm Grate/Utility Hazard?	N/A
	Obstruction Type			Storm Grate/Utility Type	
		N/A			N/A
			Yes	Surface Condition? (G/P)	Good

Remove & Replace Curb Ramp With Two New Directional Ramps or Equivalent.
