Access Compliance Report Public Rights-of-Way (Curb Ramps)

Intersection ID: 23101 Main Street: LYNBRIDGE_DR Cross Street: PROVIDENCE_RD Location: NW

ADA ID: 170C000A8C24 Ramp Type: Perp Initial Pass/Fail: Fail Overall Compliance: No Severity Score: 13.75

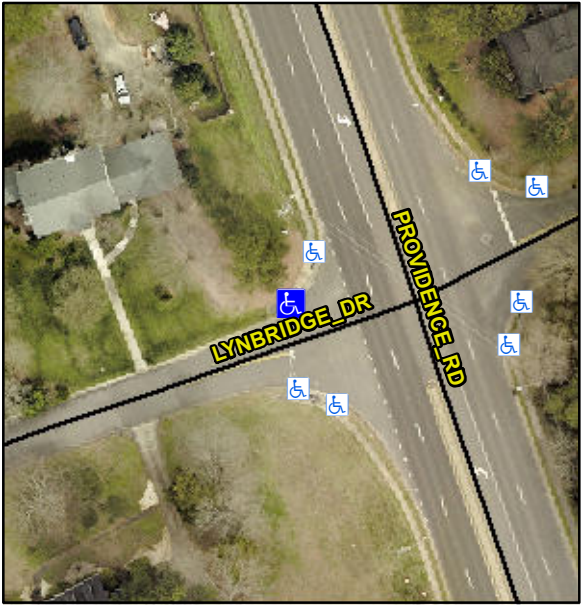
Compliance	Description	Data	Compliance	Description	Data
N/A	Ramp Length (in)	72.0	No	Ramp Slope (%)	9.2
Yes	Ramp Width (in)	50.0	No	Ramp XSlope (%)	4.9
N/A	Flare Type LT	N/A	N/A	Flare Type RT	N/A
N/A	Flare Slope LT (%)	N/A	N/A	Flare Slope RT (%)	N/A
N/A	Flare Traversable LT?	N/A	N/A	Flare Traversable RT?	N/A
N/A	Landing Length (in)	N/A	N/A	DWS Provided?	N/A
N/A	Landing Width (in)	N/A	N/A	DWS Contrast?	N/A
N/A	Landing Slope (%)	N/A	N/A	DWS Length (in)	N/A
N/A	Landing X Slope (%)	N/A	N/A	DWS Full Width?	N/A
N/A	Landing Curb? (Y/N)	N/A	N/A	DWS Offset (in)	N/A
N/A	Shared Landing?	N/A			
N/A	Gutter Ponding?	N/A	N/A	Gutter Slope (%)	N/A
N/A	Gutter Lip Ht (in)	N/A	N/A	Gutter X Slope (%)	N/A
N/A	Painted X Walk1?	No	N/A	Painted X Walk2?	N/A
	X Walk 1 Direction	To S		X Walk 2 Direction	N/A
N/A	X Walk 1 Width (in)	N/A	N/A	X Walk 2 Width (in)	N/A
	X Walk 1 Slope (%)	4.0		X Walk 2 Slope (%)	N/A
	X Walk 1 X Slope (%)	0.6		X Walk 2 X Slope (%)	N/A

N/A	Ramp inside XWalk1?	N/A	N/A	Ramp inside XWalk2?	N/A
	Road Slope (%)	N/A	N/A	Clear Space?	N/A
	Road X Slope (%)	N/A	N/A	Clear Space to XWalk (in)	N/A
N/A	Any Obstructions?	N/A	N/A	Storm Grate/Utility Hazard?	N/A
	Obstruction Type			Storm Grate/Utility Type	
			N/A		N/A
			Yes	Surface Condition? (G/P)	Good

Possible Solutions:
Remove & Replace Entire Ramp.

PROW/ADA:
R304.2.2, R304.5.3
