Access Compliance Report

Public Rights-of-Way

(Curb Ramps)

Intersection ID: 14975	Main Street: MEACHAM_ST	Cross Street: WINTHROP_AV	Location: SW
ADA ID: 170DDA81F47C	Ramp Type: PerpDiag	Initial Pass/Fail: Fail	Overall Compliance: No
			Severity Score: 21.25

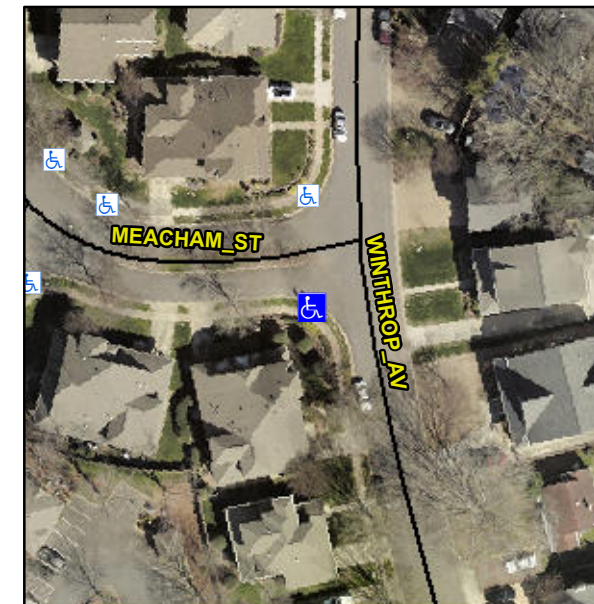
Compliance	Description	Data	Compliance	Description	Data
N/A	Ramp Length (in)	62.0	Yes	Ramp Slope (%)	7.6
No	Ramp Width (in)	42.0	No	Ramp XSlope (%)	5.3
N/A	Flare Type LT	N/A	N/A	Flare Type RT	N/A
N/A	Flare Slope LT (%)	N/A	N/A	Flare Slope RT (%)	N/A
N/A	Flare Traversable LT?	N/A	N/A	Flare Traversable RT?	N/A
N/A	Landing Length (in)	N/A	N/A	DWS Provided?	N/A
N/A	Landing Width (in)	N/A	N/A	DWS Contrast?	N/A
N/A	Landing Slope (%)	N/A	N/A	DWS Length (in)	N/A
N/A	Landing X Slope (%)	N/A	N/A	DWS Full Width?	N/A
N/A	Landing Curb? (Y/N)	N/A	N/A	DWS Offset (in)	N/A
N/A	Shared Landing?	N/A			
N/A	Gutter Ponding?	N/A	N/A	Gutter Slope (%)	N/A
N/A	Gutter Lip Ht (in)	N/A	N/A	Gutter X Slope (%)	N/A
N/A	Painted X Walk1?	No	N/A	Painted X Walk2?	No
	X Walk 1 Direction	To E		X Walk 2 Direction	To N
N/A	X Walk 1 Width (in)	N/A	N/A	X Walk 2 Width (in)	N/A
	X Walk 1 Slope (%)	3.8		X Walk 2 Slope (%)	1.0
	X Walk 1 X Slope (%)	3.3		X Walk 2 X Slope (%)	1.2

N/A	Ramp inside XWalk1?	N/A	N/A	Ramp inside XWalk2?	N/A
	Road Slope (%)	3.4	N/A	Clear Space?	N/A
	Road X Slope (%)	1.2	N/A	Clear Space to XWalk (in)	N/A
N/A	Any Obstructions?	N/A	N/A	Storm Grate/Utility Hazard?	N/A
	Obstruction Type			Storm Grate/Utility Type	
		N/A			N/A
			Yes	Surface Condition? (G/P)	Good

Remove & Replace Curb Ramp With Two New Directional Ramps or Equivalent.

Not Found, R304.5.1, R304.5.3
