Access Compliance Report

Public Rights-of-Way

(Curb Ramps)

Intersection ID: 31317	Main Street: BURNABY_CT	Cross Street: MCADAM_WY	Location: NE
ADA ID: 1714C1319B6E	Ramp Type: PerpDiag	Initial Pass/Fail: Fail	Overall Compliance: No
Severity Score: 30			
Codes/Mitigation Info/Possible Solution		Field Measurements/Component Compliance

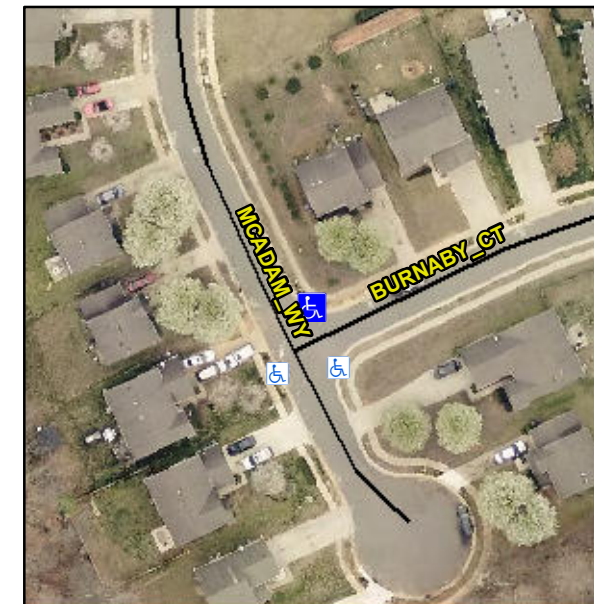
Compliance	Description	Data	Compliance	Description	Data
N/A	Ramp Length (in)	49.0	Yes	Ramp Slope (%)	6.9
No	Ramp Width (in)	34.0	No	Ramp XSlope (%)	6.4
N/A	Flare Type LT	N/A	N/A	Flare Type RT	N/A
N/A	Flare Slope LT (%)	N/A	N/A	Flare Slope RT (%)	N/A
N/A	Flare Traversable LT?	N/A	N/A	Flare Traversable RT?	N/A
N/A	Landing Length (in)	N/A	N/A	DWS Provided?	N/A
N/A	Landing Width (in)	N/A	N/A	DWS Contrast?	N/A
N/A	Landing Slope (%)	N/A	N/A	DWS Length (in)	N/A
N/A	Landing X Slope (%)	N/A	N/A	DWS Full Width?	N/A
N/A	Landing Curb? (Y/N)	N/A	N/A	DWS Offset (in)	N/A
N/A	Shared Landing?	N/A			
N/A	Gutter Ponding?	N/A	N/A	Gutter Slope (%)	N/A
N/A	Gutter Lip Ht (in)	N/A	N/A	Gutter X Slope (%)	N/A
N/A	Painted X Walk1?	No	N/A	Painted X Walk2?	No
	X Walk 1 Direction	To W		X Walk 2 Direction	To S
N/A	X Walk 1 Width (in)	N/A	N/A	X Walk 2 Width (in)	N/A
	X Walk 1 Slope (%)	3.2		X Walk 2 Slope (%)	3.7
	X Walk 1 X Slope (%)	4.7		X Walk 2 X Slope (%)	4.6

N/A	Ramp inside XWalk1?	N/A	N/A	Ramp inside XWalk2?	N/A
	Road Slope (%)	5.4	N/A	Clear Space?	N/A
	Road X Slope (%)	0.1	N/A	Clear Space to XWalk (in)	N/A
N/A	Any Obstructions?	N/A	N/A	Storm Grate/Utility Hazard?	N/A
	Obstruction Type			Storm Grate/Utility Type	
		N/A			N/A
			Yes	Surface Condition? (G/P)	Good

Possible Solutions:

Remove & Replace Curb Ramp With Two New Directional Ramps or Equivalent.
