Access Compliance Report

Public Rights-of-Way

(Curb Ramps)

Intersection ID: 15477	Main Street: W_TYVOLA_RD	Cross Street: CASCADE_POINTE_BV	Location: E
ADA ID: 171B4FFA67A1	Ramp Type: Perp	Initial Pass/Fail: Fail	Overall Compliance: No
Severity Score: 21.25			
Codes/Mitigation Info/Possible Solution		Field Measurements/Component Compliance

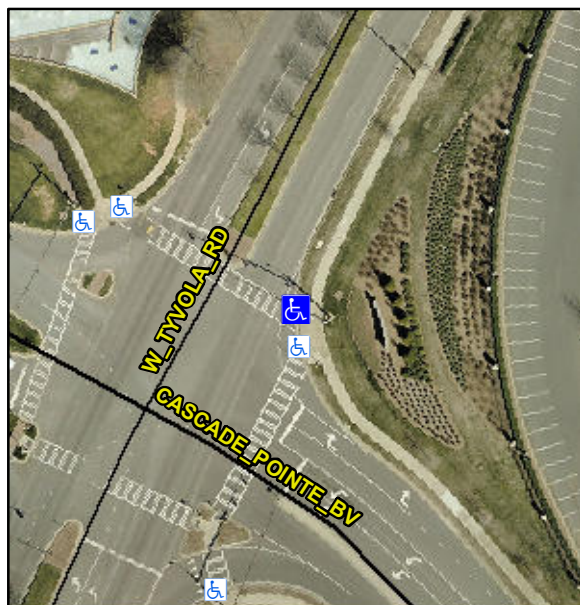
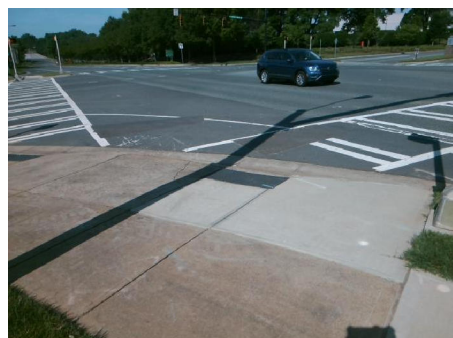
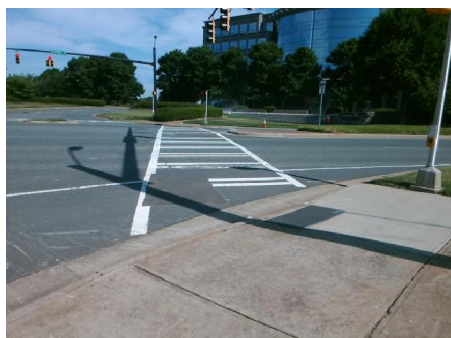
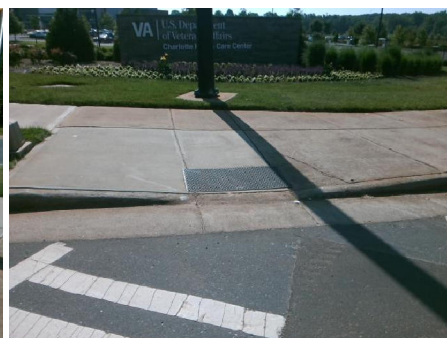
Not Found, R304.5.1, R304.5.3

Compliance	Description	Data	Compliance	Description	Data
N/A	Ramp Length (in)	185.0	Yes	Ramp Slope (%)	7.2
No	Ramp Width (in)	43.0	No	Ramp XSlope (%)	5.8
N/A	Flare Type LT	N/A	N/A	Flare Type RT	N/A
N/A	Flare Slope LT (%)	N/A	N/A	Flare Slope RT (%)	N/A
N/A	Flare Traversable LT?	N/A	N/A	Flare Traversable RT?	N/A
N/A	Landing Length (in)	N/A	N/A	DWS Provided?	N/A
N/A	Landing Width (in)	N/A	N/A	DWS Contrast?	N/A
N/A	Landing Slope (%)	N/A	N/A	DWS Length (in)	N/A
N/A	Landing X Slope (%)	N/A	N/A	DWS Full Width?	N/A
N/A	Landing Curb? (Y/N)	N/A	N/A	DWS Offset (in)	N/A
N/A	Shared Landing?	N/A			
N/A	Gutter Ponding?	N/A	N/A	Gutter Slope (%)	N/A
N/A	Gutter Lip Ht (in)	N/A	N/A	Gutter X Slope (%)	N/A
N/A	Painted X Walk1?	Yes	N/A	Painted X Walk2?	N/A
	X Walk 1 Direction	To NW		X Walk 2 Direction	N/A
N/A	X Walk 1 Width (in)	118.0	N/A	X Walk 2 Width (in)	N/A
	X Walk 1 Slope (%)	6.2		X Walk 2 Slope (%)	N/A
	X Walk 1 X Slope (%)	0.9		X Walk 2 X Slope (%)	N/A

N/A	Ramp inside XWalk1?	Yes	N/A	Ramp inside XWalk2?	N/A
	Road Slope (%)	N/A	N/A	Clear Space?	N/A
	Road X Slope (%)	N/A	N/A	Clear Space to XWalk (in)	N/A
N/A	Any Obstructions?	N/A	N/A	Storm Grate/Utility Hazard?	N/A
	Obstruction Type			Storm Grate/Utility Type	
		N/A			N/A
			Yes	Surface Condition? (G/P)	Good

Possible Solutions:

Remove & Replace Entire Ramp.
