Access Compliance Report

Public Rights-of-Way

(Curb Ramps)

Intersection ID: 30374	Main Street: EASTWAY_CROSSING_DR	Cross Street: EASTWAY_DR	Location: SW
ADA ID: 171F9A8825EA	Ramp Type: Perp	Initial Pass/Fail: Fail	Overall Compliance: No
		Severity Score: 12.5

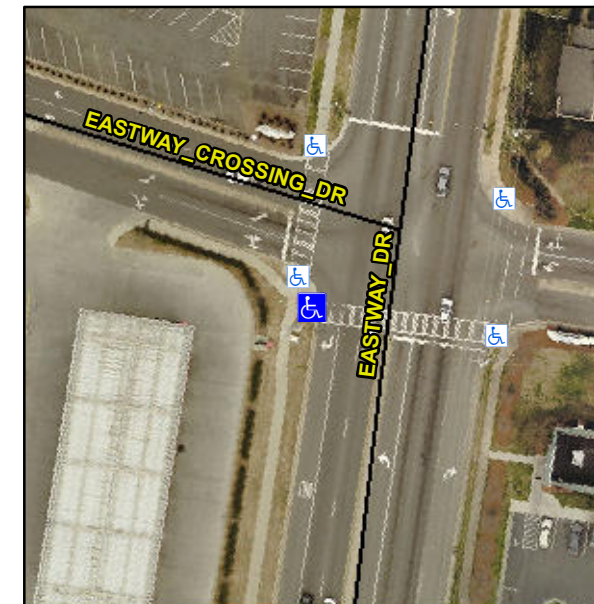
Not Found, R304.2.2

Compliance	Description	Data	Compliance	Description	Data
N/A	Ramp Length (in)	102.5	No	Ramp Slope (%)	8.7
Yes	Ramp Width (in)	72.0	Yes	Ramp XSlope (%)	1.4
N/A	Flare Type LT	N/A	N/A	Flare Type RT	N/A
N/A	Flare Slope LT (%)	N/A	N/A	Flare Slope RT (%)	N/A
N/A	Flare Traversable LT?	N/A	N/A	Flare Traversable RT?	N/A
N/A	Landing Length (in)	N/A	N/A	DWS Provided?	N/A
N/A	Landing Width (in)	N/A	N/A	DWS Contrast?	N/A
N/A	Landing Slope (%)	N/A	N/A	DWS Length (in)	N/A
N/A	Landing X Slope (%)	N/A	N/A	DWS Full Width?	N/A
N/A	Landing Curb? (Y/N)	N/A	N/A	DWS Offset (in)	N/A
N/A	Shared Landing?	N/A			
N/A	Gutter Ponding?	N/A	N/A	Gutter Slope (%)	N/A
N/A	Gutter Lip Ht (in)	0.5	N/A	Gutter X Slope (%)	N/A
N/A	Painted X Walk1?	Yes	N/A	Painted X Walk2?	N/A
	X Walk 1 Direction	To E		X Walk 2 Direction	N/A
N/A	X Walk 1 Width (in)	110.0	N/A	X Walk 2 Width (in)	N/A
	X Walk 1 Slope (%)	3.3		X Walk 2 Slope (%)	N/A
	X Walk 1 X Slope (%)	2.0		X Walk 2 X Slope (%)	N/A

N/A	Ramp inside XWalk1?	Yes	N/A	Ramp inside XWalk2?	N/A
	Road Slope (%)	N/A	N/A	Clear Space?	N/A
	Road X Slope (%)	N/A	N/A	Clear Space to XWalk (in)	N/A
N/A	Any Obstructions?	N/A	N/A	Storm Grate/Utility Hazard?	N/A
	Obstruction Type			Storm Grate/Utility Type	
		N/A			N/A
			Yes	Surface Condition? (G/P)	Good

Remove & Replace Entire Ramp.
