# Access Compliance Report

## Public Rights-of-Way

### (Curb Ramps)

Intersection ID: 49800	Main Street: MATARESE_CT	Cross Street: PARSIFAL_LN	Location:	N
ADA ID: 1726F9B6B1DB	Ramp Type: PerpDiag	Initial Pass/Fail: Fail	Overall Compliance: No	Severity Score: 21.25
Codes/Mitigation Info/Possible Solution		Field Measurements/Component Compliance

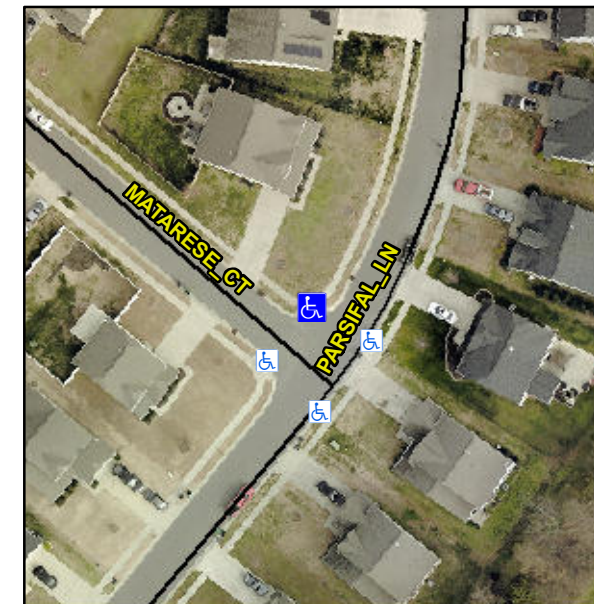
**Not Found, R304.5.1, R304.2.2**

Compliance	Description	Data	Compliance	Description	Data
N/A	Ramp Length (in)	46.0	No	Ramp Slope (%)	11.2
No	Ramp Width (in)	47.0	Yes	Ramp XSlope (%)	0.3
N/A	Flare Type LT	N/A	N/A	Flare Type RT	N/A
N/A	Flare Slope LT (%)	N/A	N/A	Flare Slope RT (%)	N/A
N/A	Flare Traversable LT?	N/A	N/A	Flare Traversable RT?	N/A
N/A	Landing Length (in)	N/A	N/A	DWS Provided?	N/A
N/A	Landing Width (in)	N/A	N/A	DWS Contrast?	N/A
N/A	Landing Slope (%)	N/A	N/A	DWS Length (in)	N/A
N/A	Landing X Slope (%)	N/A	N/A	DWS Full Width?	N/A
N/A	Landing Curb? (Y/N)	N/A	N/A	DWS Offset (in)	N/A
N/A	Shared Landing?	N/A			
N/A	Gutter Ponding?	N/A	N/A	Gutter Slope (%)	N/A
N/A	Gutter Lip Ht (in)	N/A	N/A	Gutter X Slope (%)	N/A
N/A	Painted X Walk1?	No	N/A	Painted X Walk2?	No
	X Walk 1 Direction	To SW		X Walk 2 Direction	To SE
N/A	X Walk 1 Width (in)	N/A	N/A	X Walk 2 Width (in)	N/A
	X Walk 1 Slope (%)	1.3		X Walk 2 Slope (%)	2.5
	X Walk 1 X Slope (%)	0.1		X Walk 2 X Slope (%)	0.8

N/A	Ramp inside XWalk1?	N/A	N/A	Ramp inside XWalk2?	N/A
	Road Slope (%)	1.8	N/A	Clear Space?	N/A
	Road X Slope (%)	0.3	N/A	Clear Space to XWalk (in)	N/A
N/A	Any Obstructions?	N/A	N/A	Storm Grate/Utility Hazard?	N/A
	Obstruction Type			Storm Grate/Utility Type	
		N/A			N/A
			Yes	Surface Condition? (G/P)	Good

**Remove & Replace Curb Ramp With Two New Directional Ramps or Equivalent.**
