Access Compliance Report

Public Rights-of-Way

(Curb Ramps)

Intersection ID: 47839	Main Street: PECO_RD	Cross Street: ALVARADO_WY	Location: NW
ADA ID: 17321AA2C394	Ramp Type: Perp	Initial Pass/Fail: Fail	Overall Compliance: No
Severity Score: 8.75			
Codes/Mitigation Info/Possible Solution		Field Measurements/Component Compliance

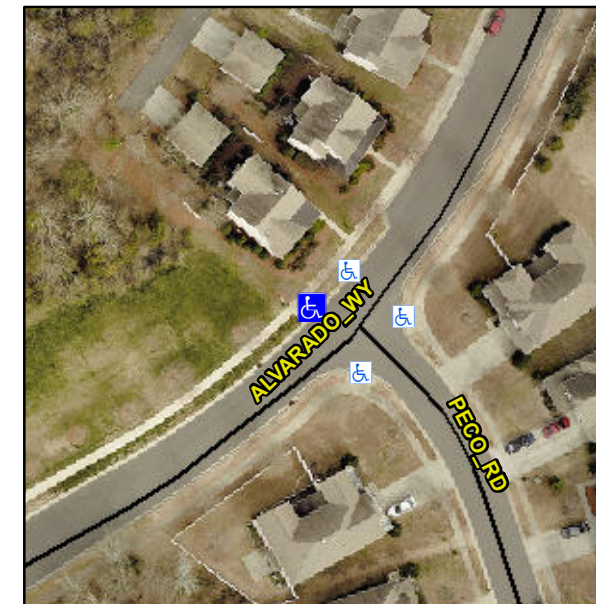
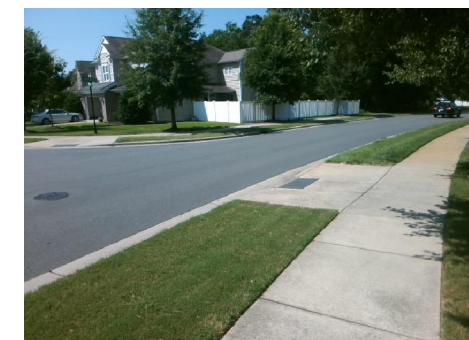
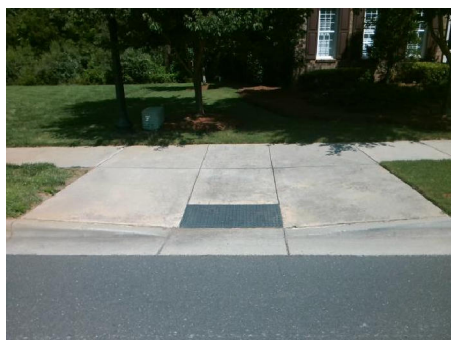
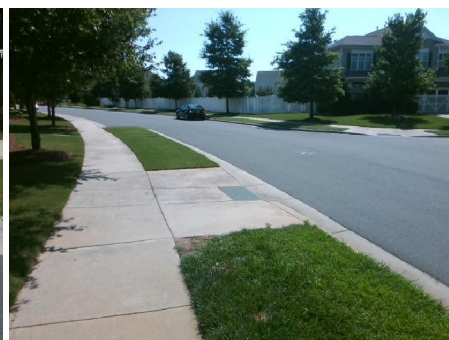
Compliance	Description	Data	Compliance	Description	Data
N/A	Ramp Length (in)	133.0	Yes	Ramp Slope (%)	7.3
No	Ramp Width (in)	47.0	Yes	Ramp XSlope (%)	1.0
N/A	Flare Type LT	N/A	N/A	Flare Type RT	N/A
N/A	Flare Slope LT (%)	N/A	N/A	Flare Slope RT (%)	N/A
N/A	Flare Traversable LT?	N/A	N/A	Flare Traversable RT?	N/A
N/A	Landing Length (in)	N/A	N/A	DWS Provided?	N/A
N/A	Landing Width (in)	N/A	N/A	DWS Contrast?	N/A
N/A	Landing Slope (%)	N/A	N/A	DWS Length (in)	N/A
N/A	Landing X Slope (%)	N/A	N/A	DWS Full Width?	N/A
N/A	Landing Curb? (Y/N)	N/A	N/A	DWS Offset (in)	N/A
N/A	Shared Landing?	N/A			
N/A	Gutter Ponding?	N/A	N/A	Gutter Slope (%)	N/A
N/A	Gutter Lip Ht (in)	N/A	N/A	Gutter X Slope (%)	N/A
N/A	Painted X Walk1?	No	N/A	Painted X Walk2?	N/A
	X Walk 1 Direction	To SE		X Walk 2 Direction	N/A
N/A	X Walk 1 Width (in)	N/A	N/A	X Walk 2 Width (in)	N/A
	X Walk 1 Slope (%)	3.1		X Walk 2 Slope (%)	N/A
	X Walk 1 X Slope (%)	1.2		X Walk 2 X Slope (%)	N/A

N/A	Ramp inside XWalk1?	N/A	N/A	Ramp inside XWalk2?	N/A
	Road Slope (%)	N/A	N/A	Clear Space?	N/A
	Road X Slope (%)	N/A	N/A	Clear Space to XWalk (in)	N/A
N/A	Any Obstructions?	N/A	N/A	Storm Grate/Utility Hazard?	N/A
	Obstruction Type			Storm Grate/Utility Type	
		N/A			N/A
		Yes		Surface Condition? (G/P)	Good

Possible Solutions:

Remove & Replace Entire Ramp.

PROW/ADA:

R304.5.1
