# Access Compliance Report

## Public Rights-of-Way

### (Curb Ramps)

Intersection ID: 27404	Main Street: BALLANTYNE COMMONS PY	Cross Street: MEADOW RUN LN	Location: SE
ADA ID: 174D761178C5	Ramp Type: Perp	Initial Pass/Fail: Fail	Overall Compliance: No
		Severity Score: 8.75	
Codes/Mitigation Info/Possible Solution		Field Measurements/Component Compliance

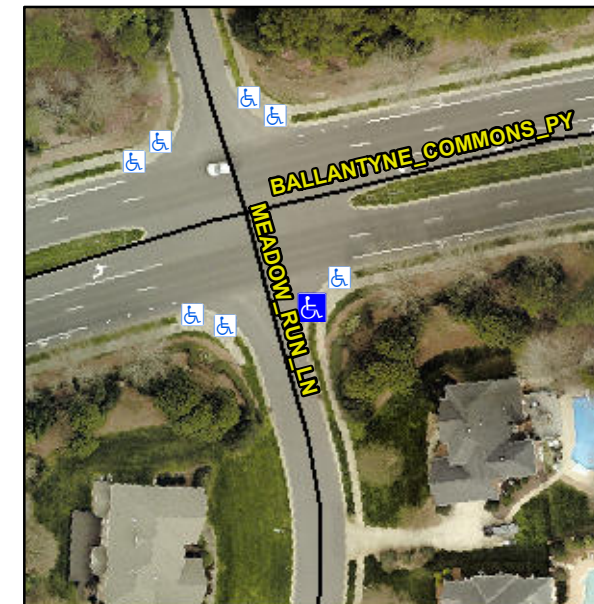
**Not Found, R304.5.1**

Compliance	Description	Data	Compliance	Description	Data
N/A	Ramp Length (in)	69.0	Yes	Ramp Slope (%)	7.5
No	Ramp Width (in)	43.5	Yes	Ramp XSlope (%)	0.5
N/A	Flare Type LT	N/A	N/A	Flare Type RT	N/A
N/A	Flare Slope LT (%)	N/A	N/A	Flare Slope RT (%)	N/A
N/A	Flare Traversable LT?	N/A	N/A	Flare Traversable RT?	N/A
N/A	Landing Length (in)	N/A	N/A	DWS Provided?	N/A
N/A	Landing Width (in)	N/A	N/A	DWS Contrast?	N/A
N/A	Landing Slope (%)	N/A	N/A	DWS Length (in)	N/A
N/A	Landing X Slope (%)	N/A	N/A	DWS Full Width?	N/A
N/A	Landing Curb? (Y/N)	N/A	N/A	DWS Offset (in)	N/A
N/A	Shared Landing?	N/A			
N/A	Gutter Ponding?	N/A	N/A	Gutter Slope (%)	N/A
N/A	Gutter Lip Ht (in)	N/A	N/A	Gutter X Slope (%)	N/A
N/A	Painted X Walk1?	No	N/A	Painted X Walk2?	N/A
	X Walk 1 Direction	To W		X Walk 2 Direction	N/A
N/A	X Walk 1 Width (in)	N/A	N/A	X Walk 2 Width (in)	N/A
	X Walk 1 Slope (%)	1.9		X Walk 2 Slope (%)	N/A
	X Walk 1 X Slope (%)	0.4		X Walk 2 X Slope (%)	N/A

N/A	Ramp inside XWalk1?	N/A	N/A	Ramp inside XWalk2?	N/A
	Road Slope (%)	N/A	N/A	Clear Space?	N/A
	Road X Slope (%)	N/A	N/A	Clear Space to XWalk (in)	N/A
N/A	Any Obstructions?	N/A	N/A	Storm Grate/Utility Hazard?	N/A
	Obstruction Type			Storm Grate/Utility Type	
		N/A			N/A
			Yes	Surface Condition? (G/P)	Good

Possible Solutions:

**Remove & Replace Entire Ramp.**

Total Cost: \$ 1850.00
