Access Compliance Report

Public Rights-of-Way

(Curb Ramps)

Intersection ID: 44217	Main Street: HENNIGAN_PLACE_LN	Cross Street: ROZZELLES_LANDING_DR	Location: SE
ADA ID: 174DD6464260	Ramp Type: Perp	Initial Pass/Fail: Fail	Overall Compliance: No
Severity Score: 10			
Codes/Mitigation Info/Possible Solution		Field Measurements/Component Compliance

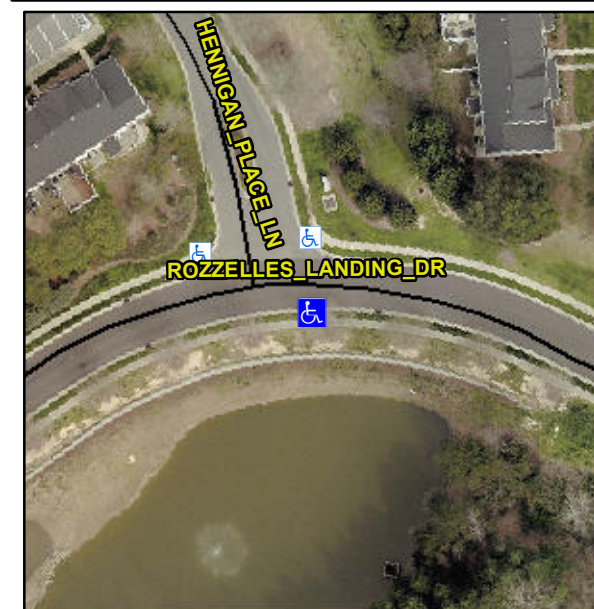
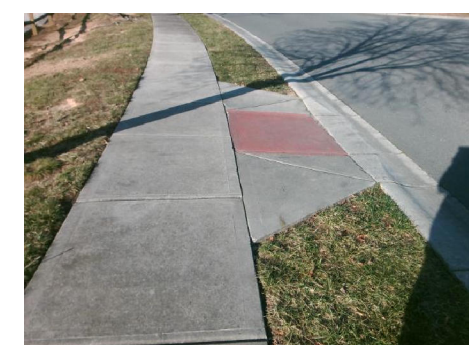
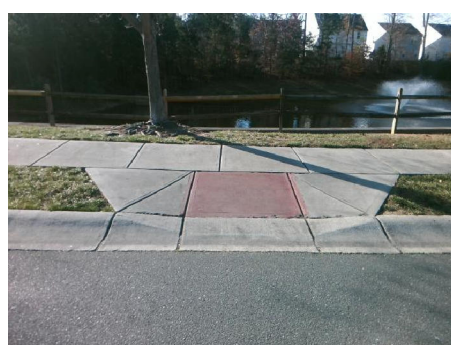
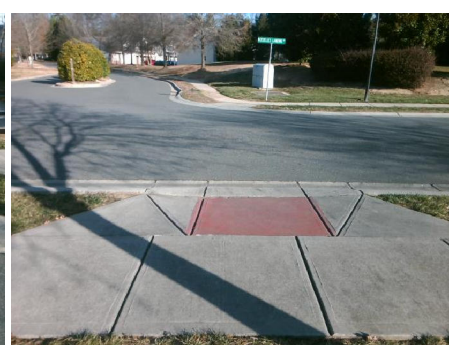
Not Found, R304.5.1, R304.5.3

Compliance	Description	Data	Compliance	Description	Data
N/A	Ramp Length (in)	48.0	Yes	Ramp Slope (%)	7.2
No	Ramp Width (in)	47.5	No	Ramp XSlope (%)	2.1
N/A	Flare Type LT	N/A	N/A	Flare Type RT	N/A
N/A	Flare Slope LT (%)	N/A	N/A	Flare Slope RT (%)	N/A
N/A	Flare Traversable LT?	N/A	N/A	Flare Traversable RT?	N/A
N/A	Landing Length (in)	N/A	N/A	DWS Provided?	N/A
N/A	Landing Width (in)	N/A	N/A	DWS Contrast?	N/A
N/A	Landing Slope (%)	N/A	N/A	DWS Length (in)	N/A
N/A	Landing X Slope (%)	N/A	N/A	DWS Full Width?	N/A
N/A	Landing Curb? (Y/N)	N/A	N/A	DWS Offset (in)	N/A
N/A	Shared Landing?	N/A			
N/A	Gutter Ponding?	N/A	N/A	Gutter Slope (%)	N/A
N/A	Gutter Lip Ht (in)	N/A	N/A	Gutter X Slope (%)	N/A
N/A	Painted X Walk1?	No	N/A	Painted X Walk2?	N/A
	X Walk 1 Direction	To N		X Walk 2 Direction	N/A
N/A	X Walk 1 Width (in)	N/A	N/A	X Walk 2 Width (in)	N/A
	X Walk 1 Slope (%)	1.7		X Walk 2 Slope (%)	N/A
	X Walk 1 X Slope (%)	1.2		X Walk 2 X Slope (%)	N/A

N/A	Ramp inside XWalk1?	N/A	N/A	Ramp inside XWalk2?	N/A
	Road Slope (%)	N/A	N/A	Clear Space?	N/A
	Road X Slope (%)	N/A	N/A	Clear Space to XWalk (in)	N/A
N/A	Any Obstructions?	N/A	N/A	Storm Grate/Utility Hazard?	N/A
	Obstruction Type			Storm Grate/Utility Type	
		N/A			N/A
			Yes	Surface Condition? (G/P)	Good

Remove & Replace Entire Ramp.

Total Cost: \$ 1850.00
