# Access Compliance Report

## Public Rights-of-Way

### (Curb Ramps)

Intersection ID: 9515	Main Street: GRIMES_ST	Cross Street: W_28TH_ST	Location:	E
ADA ID: 17500E700139	Ramp Type: PerpDiag	Initial Pass/Fail: Fail	Overall Compliance: No	Severity Score: 25

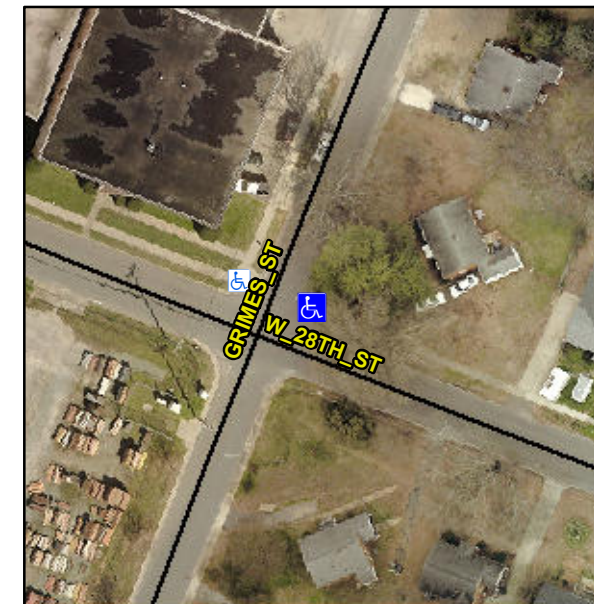
Compliance	Description	Data	Compliance	Description	Data
N/A	Ramp Length (in)	54.5	No	Ramp Slope (%)	13.4
Yes	Ramp Width (in)	54.0	Yes	Ramp XSlope (%)	2.0
N/A	Flare Type LT	N/A	N/A	Flare Type RT	N/A
N/A	Flare Slope LT (%)	N/A	N/A	Flare Slope RT (%)	N/A
N/A	Flare Traversable LT?	N/A	N/A	Flare Traversable RT?	N/A
N/A	Landing Length (in)	N/A	N/A	DWS Provided?	N/A
N/A	Landing Width (in)	N/A	N/A	DWS Contrast?	N/A
N/A	Landing Slope (%)	N/A	N/A	DWS Length (in)	N/A
N/A	Landing X Slope (%)	N/A	N/A	DWS Full Width?	N/A
N/A	Landing Curb? (Y/N)	N/A	N/A	DWS Offset (in)	N/A
N/A	Shared Landing?	N/A			
N/A	Gutter Ponding?	Yes	N/A	Gutter Slope (%)	N/A
N/A	Gutter Lip Ht (in)	N/A	N/A	Gutter X Slope (%)	N/A
N/A	Painted X Walk1?	No	N/A	Painted X Walk2?	No
	X Walk 1 Direction	To NW		X Walk 2 Direction	To SW
N/A	X Walk 1 Width (in)	N/A	N/A	X Walk 2 Width (in)	N/A
	X Walk 1 Slope (%)	6.3		X Walk 2 Slope (%)	1.5
	X Walk 1 X Slope (%)	2.2		X Walk 2 X Slope (%)	3.0

N/A	Ramp inside XWalk1?	N/A	N/A	Ramp inside XWalk2?	N/A
	Road Slope (%)	2.9	N/A	Clear Space?	N/A
	Road X Slope (%)	2.4	N/A	Clear Space to XWalk (in)	N/A
N/A	Any Obstructions?	N/A	N/A	Storm Grate/Utility Hazard?	N/A
	Obstruction Type			Storm Grate/Utility Type	
		N/A			N/A
		Yes		Surface Condition? (G/P)	Good

**Remove & Replace Curb Ramp With Two New Directional Ramps or Equivalent.**

**R304.2.2**

**\$ 3200.00**
