Access Compliance Report

Public Rights-of-Way

(Curb Ramps)

Intersection ID: N/A	Main Street: SPEER_BV	Cross Street: NATIONAL_AV	Location: S
ADA ID: 175918F7CBC3	Ramp Type: Perp	Initial Pass/Fail: Fail	Overall Compliance: No
		Severity Score: 12.5

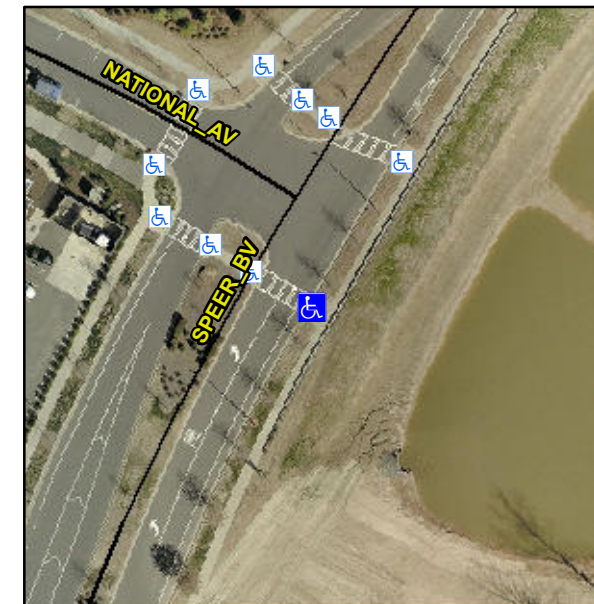
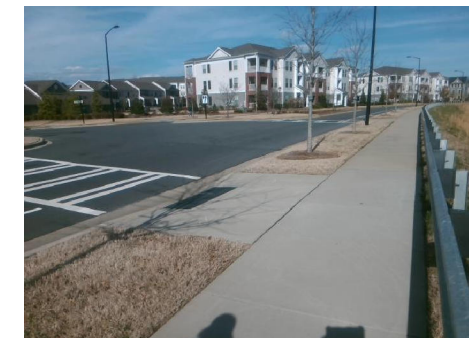
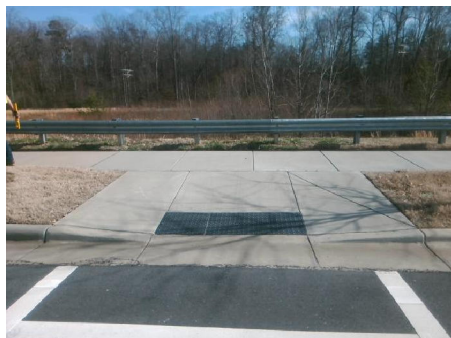
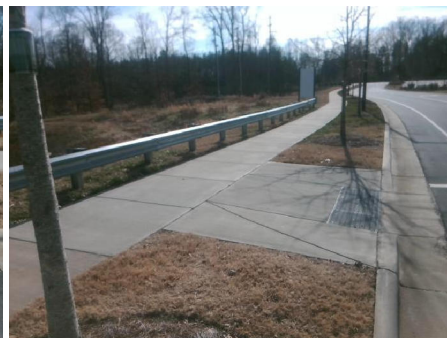
Compliance	Description	Data	Compliance	Description	Data
N/A	Ramp Length (in)	96.0	No	Ramp Slope (%)	9.9
Yes	Ramp Width (in)	70.0	Yes	Ramp XSlope (%)	1.3
N/A	Flare Type LT	N/A	N/A	Flare Type RT	N/A
N/A	Flare Slope LT (%)	N/A	N/A	Flare Slope RT (%)	N/A
N/A	Flare Traversable LT?	N/A	N/A	Flare Traversable RT?	N/A
N/A	Landing Length (in)	N/A	N/A	DWS Provided?	N/A
N/A	Landing Width (in)	N/A	N/A	DWS Contrast?	N/A
N/A	Landing Slope (%)	N/A	N/A	DWS Length (in)	N/A
N/A	Landing X Slope (%)	N/A	N/A	DWS Full Width?	N/A
N/A	Landing Curb? (Y/N)	N/A	N/A	DWS Offset (in)	N/A
N/A	Shared Landing?	N/A			
N/A	Gutter Ponding?	N/A	N/A	Gutter Slope (%)	N/A
N/A	Gutter Lip Ht (in)	N/A	N/A	Gutter X Slope (%)	N/A
N/A	Painted X Walk1?	Yes	N/A	Painted X Walk2?	N/A
	X Walk 1 Direction	To NW		X Walk 2 Direction	N/A
N/A	X Walk 1 Width (in)	112.0	N/A	X Walk 2 Width (in)	N/A
	X Walk 1 Slope (%)	4.1		X Walk 2 Slope (%)	N/A
	X Walk 1 X Slope (%)	0.5		X Walk 2 X Slope (%)	N/A

N/A	Ramp inside XWalk1?	Yes	N/A	Ramp inside XWalk2?	N/A
	Road Slope (%)	N/A	N/A	Clear Space?	N/A
	Road X Slope (%)	N/A	N/A	Clear Space to XWalk (in)	N/A
N/A	Any Obstructions?	N/A	N/A	Storm Grate/Utility Hazard?	N/A
	Obstruction Type			Storm Grate/Utility Type	
		N/A			N/A
		Yes		Surface Condition? (G/P)	Good

Remove & Replace Entire Ramp.

R304.2.2

Total Cost: \$ 1850.00
