# Access Compliance Report

## Public Rights-of-Way

### (Curb Ramps)

| Intersection ID: 14003 | Main Street: MT_VERNON_AV | Cross Street: MYRTLE_AV | Location: NW |

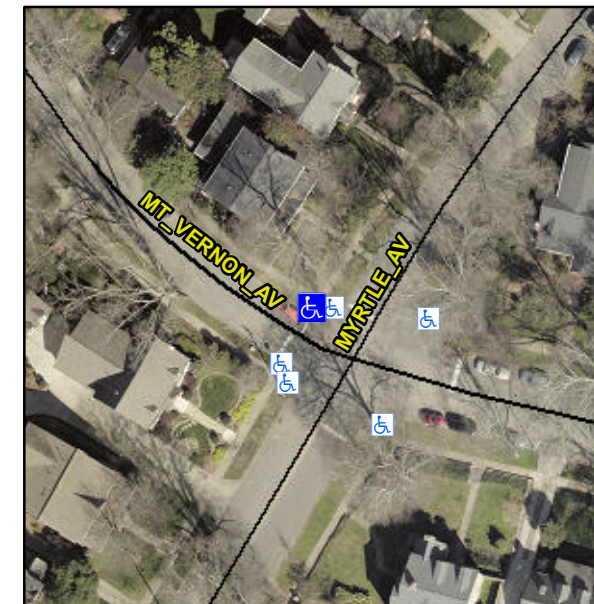
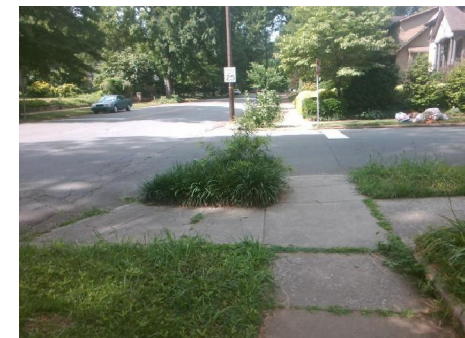
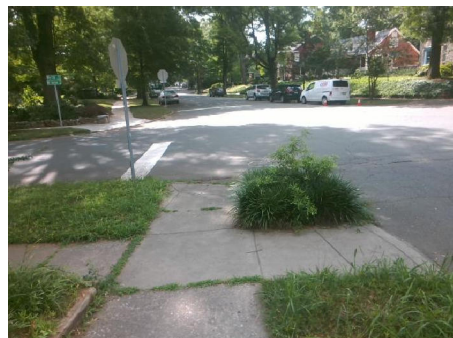
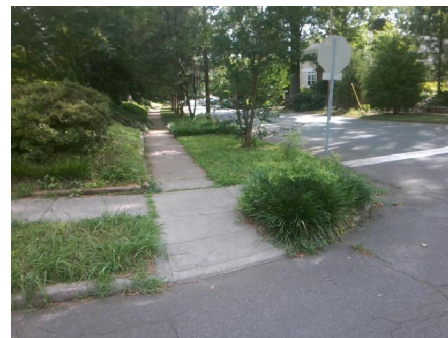
| ADA ID: 175CD337369B | Ramp Type: BlendTrans2 | Initial Pass/Fail: Fail | Overall Compliance: No |

**NO LNDG**

**R304.5.3**

| Compliance | Description | Data | Compliance | Description | Data |
|---|---|---|---|---|---|
| Yes | Ramp Width (in) | 54.0 | No | BlendTrans XSlope (%) | 4.1 |

**Remove & Replace Curb Ramp With Two New Directional Ramps or Equivalent.**

\$ 3200.00
